November 17, 2023
DRAFT REPORT

Marco Aglieco, Buildings and Facilities Manager
Town of Windsor – Building Maintenance
275 Broad Street
Windsor, CT 06095

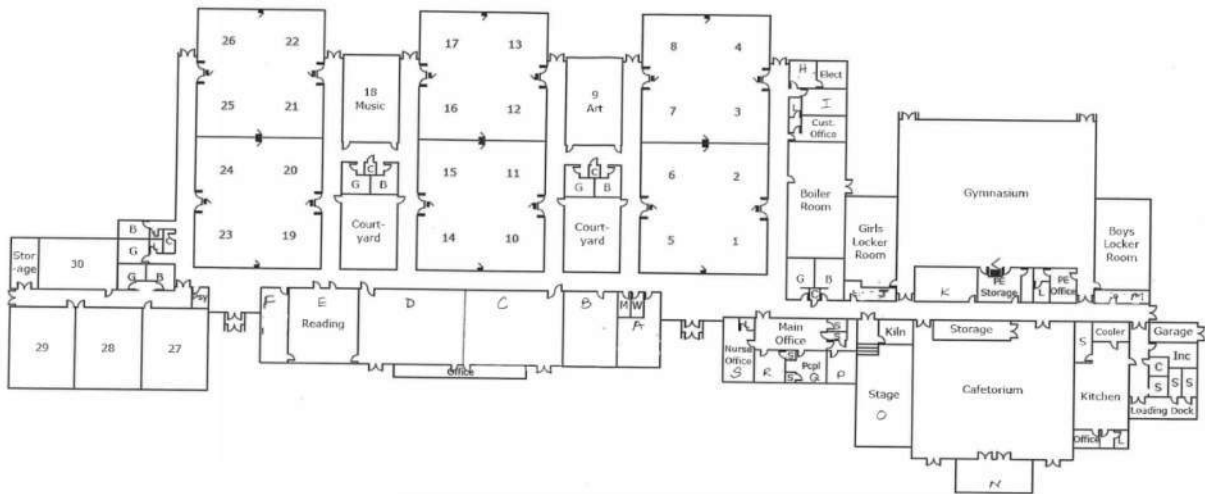
Figure 1 – Room Designation Plan used for test area designations.

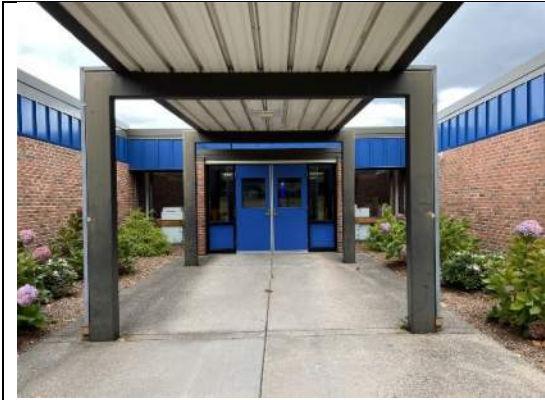
Image 1 – Exterior view of main entrance and entrance door illustration blue cladding placed over limestone elements.

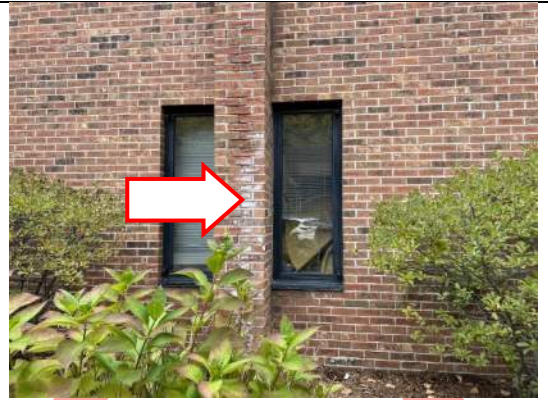
Image 2 – Atmospheric staining and efflorescence observed on face brick pier, located at the exterior side of the office space between Rooms D and C.

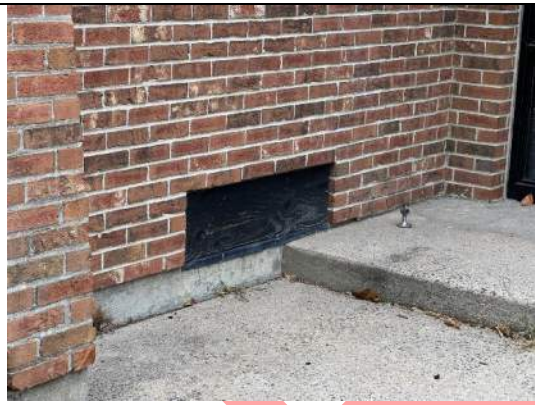
Image 3 – View of plywood infill where existing louvers were noted to be present located adjacent to the entrance to Room C.

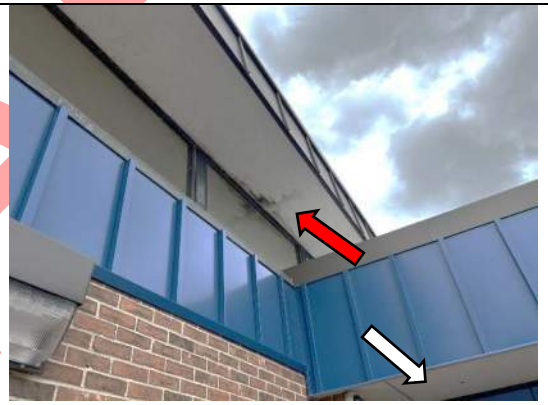
Image 4 – View of stained plywood sheets at clerestory soffit (red arrow), a condition generally observed at clerestory windows. Note: Similar looking Glasweld panels used in original construction (white arrow).

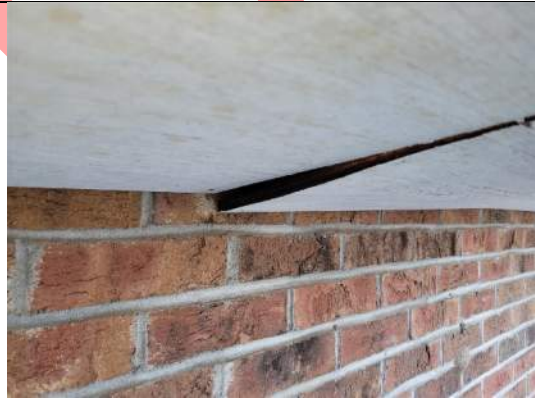
Image 5 – View of dislodged plywood soffit.

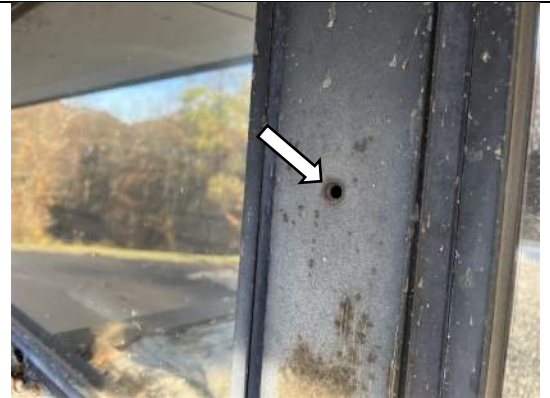
Image 8 – View of missing fastener at vertical mullion between clerestory windows. Condition observed at several locations.

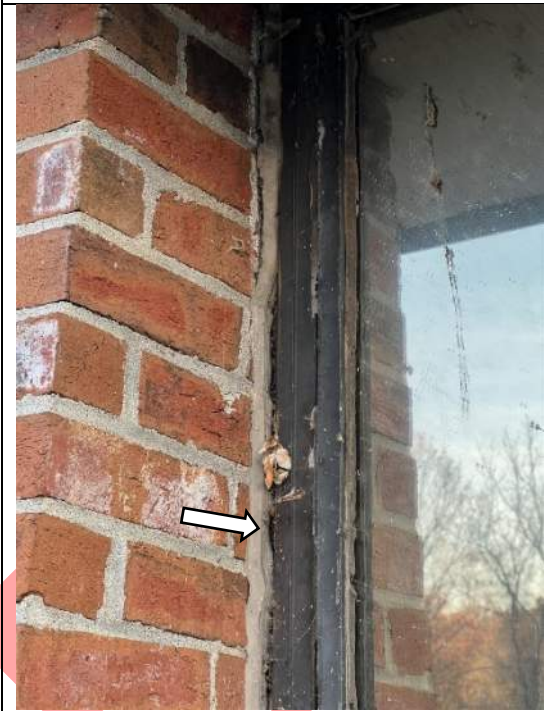
Image 9 – View of deteriorating perimeter sealant located at the exterior side of Room 26.

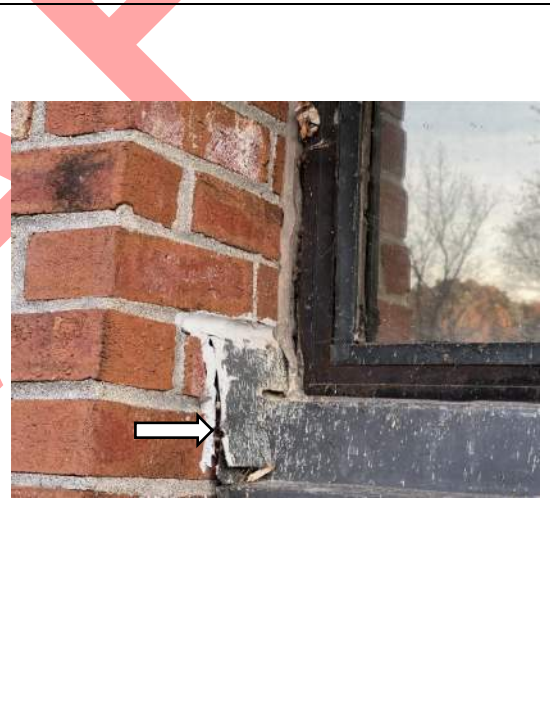
Image 10 – View of displaced flashing and failed sealants located at the exterior side of Room 26.

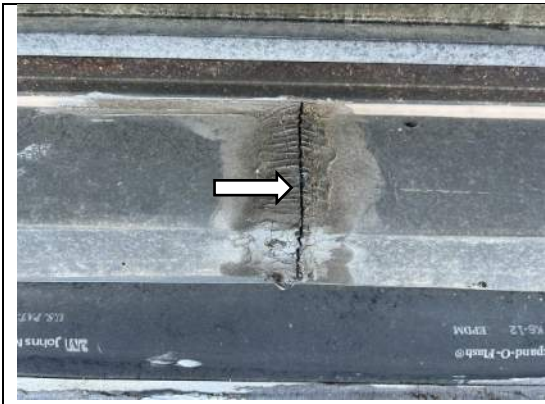
Image 11 – View of failed lap seam weld at sill flashing located beneath clerestory window. Note: Condition typical at all sill flashing joints.

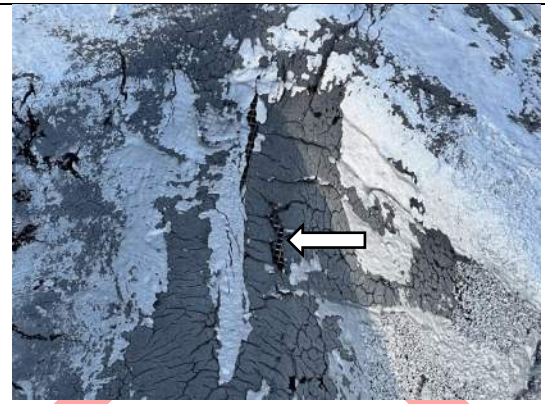
Image 12 – View of exposed reinforcing ply located at the roof above the western exit.

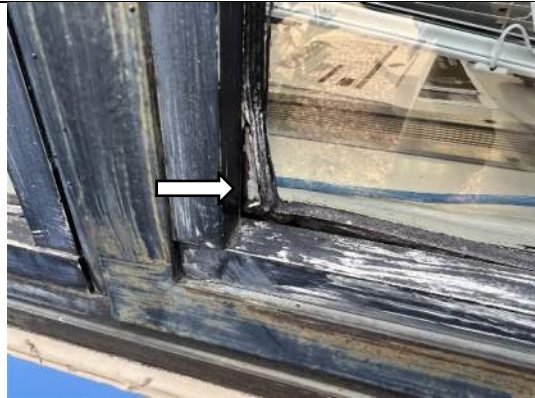
Image 13 – Representative view of failed window glazing gasket at Room S, the Nurse’s Office.

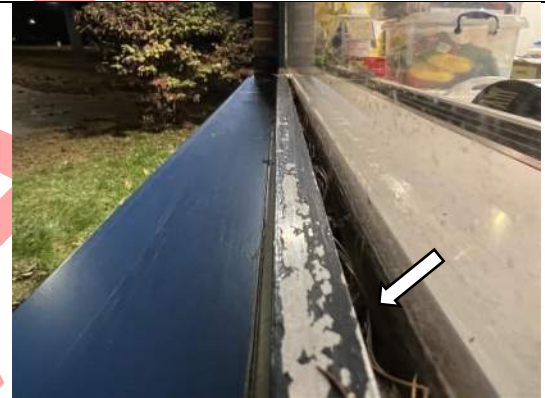
Image 14 – View of missing glazing gasketing.

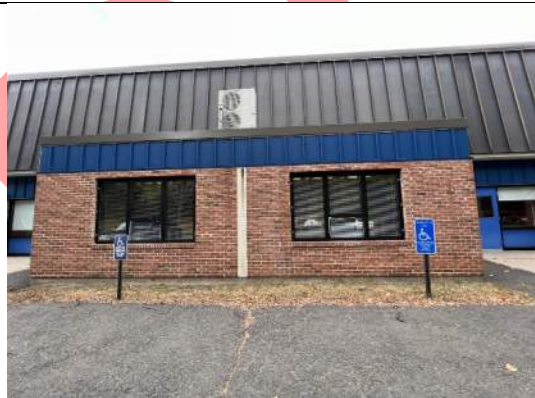
Image 15 – Partial south elevation view of Room N. New windows have been added since the original construction drawings did not indicate windows at these locations.

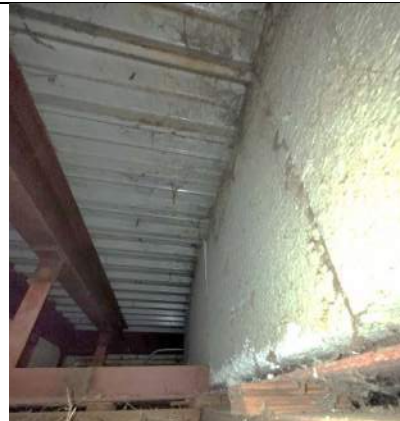
Image 16 – View of the exterior wall assembly from within the first-floor soffit. Note the spider webs and atmospheric staining between the metal roof deck and the infill extruded polystyrene (EPS) insulation.

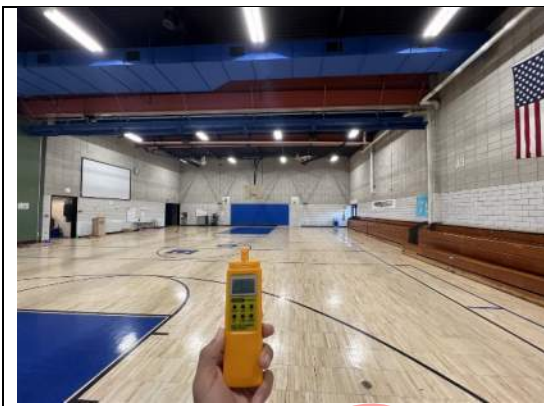
Image 17 – Overall interior view of the gymnasium. Relative humidity in the gymnasium was observed to be under 30% prior to pressurization.

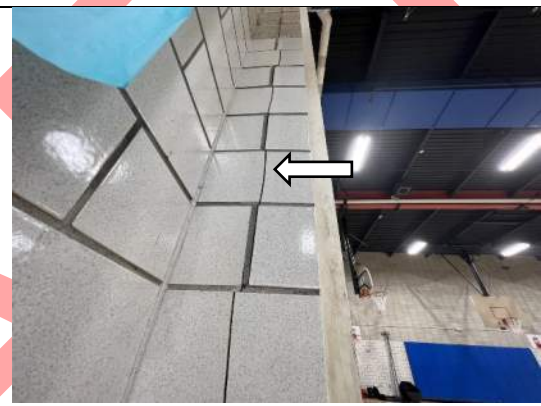
Image 18 – View of a vertical crack at interior wall chase in the gymnasium.

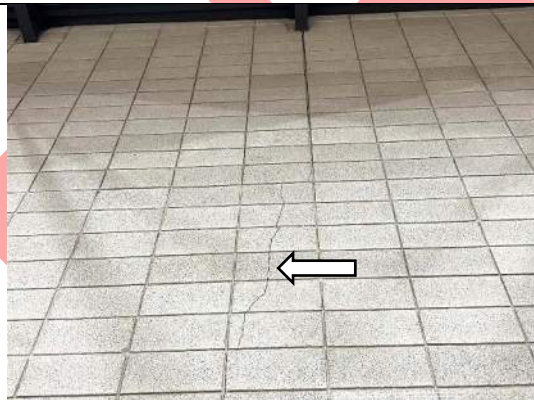
Image 19 – View of step cracking crossing both mortar joints and masonry units. Similar cracks were observed at other faces of interior walls in gymnasium.

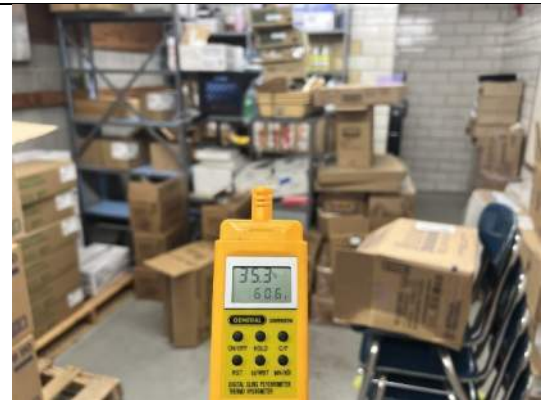
Image 20 – Overall interior view of Gymnasium. Relative humidity in the Boy’s Locker Room space was observed to be approximately 35% prior to pressurization.

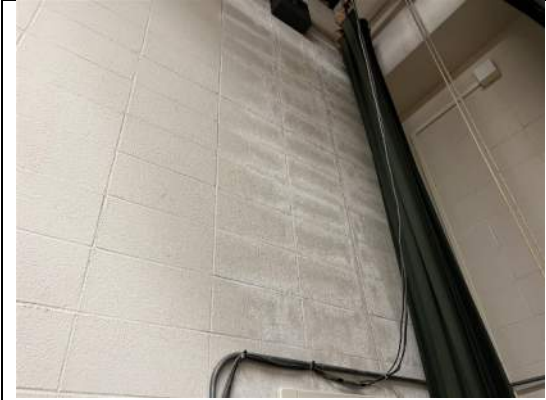
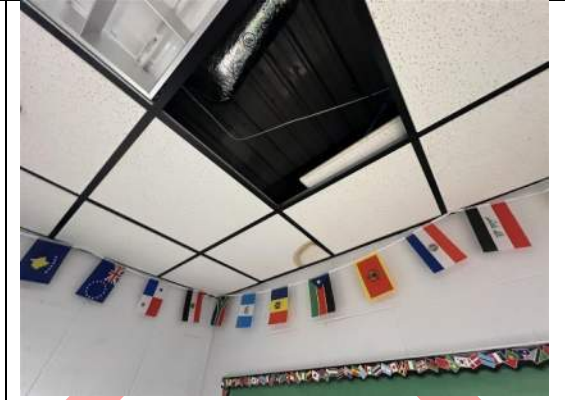
<p>Image 25 – View of what appears to be efflorescence over existing masonry unit wall, located in the Stage O space.</p>		<p>Image 26 – View of stained dropped ceiling panel, located in Room N.</p>

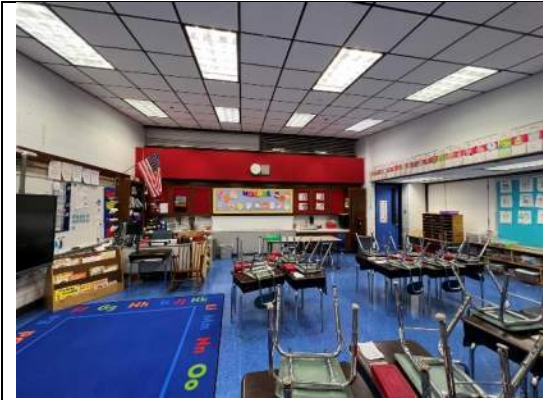
Image 27 – Overall interior view of a Pod-style classroom with the clerestory windows along the ceiling line and a bulkhead below and along both sides of the room.

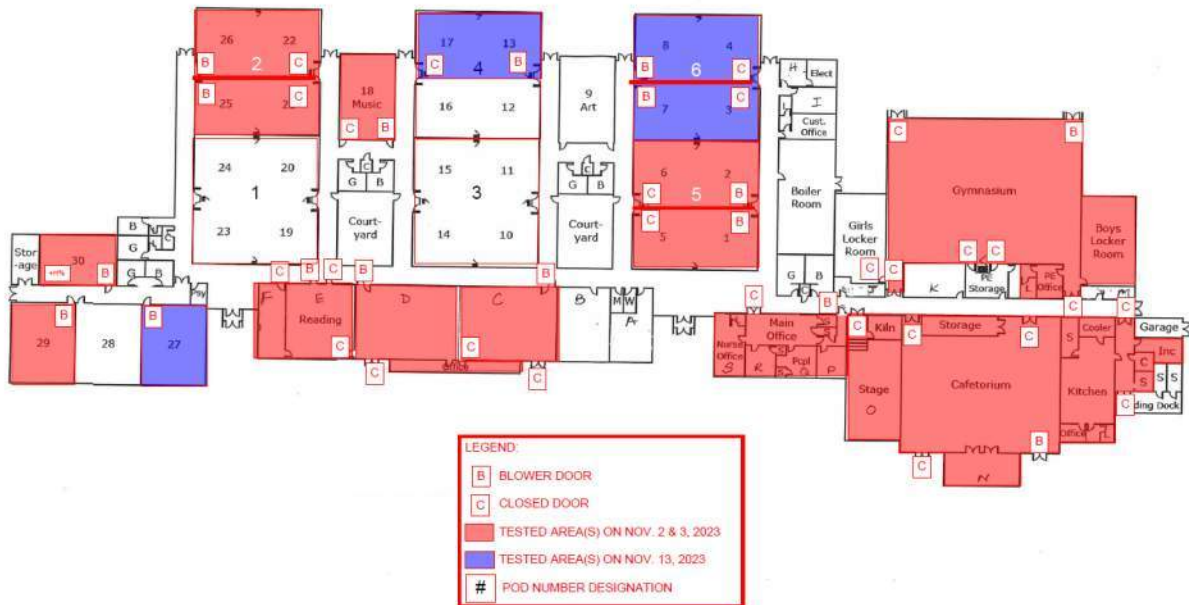
Figure 4: Redlined Room Designation Plan depicting testing areas. Classroom pods indicated by occupied grade level per the 1968 Drawings.

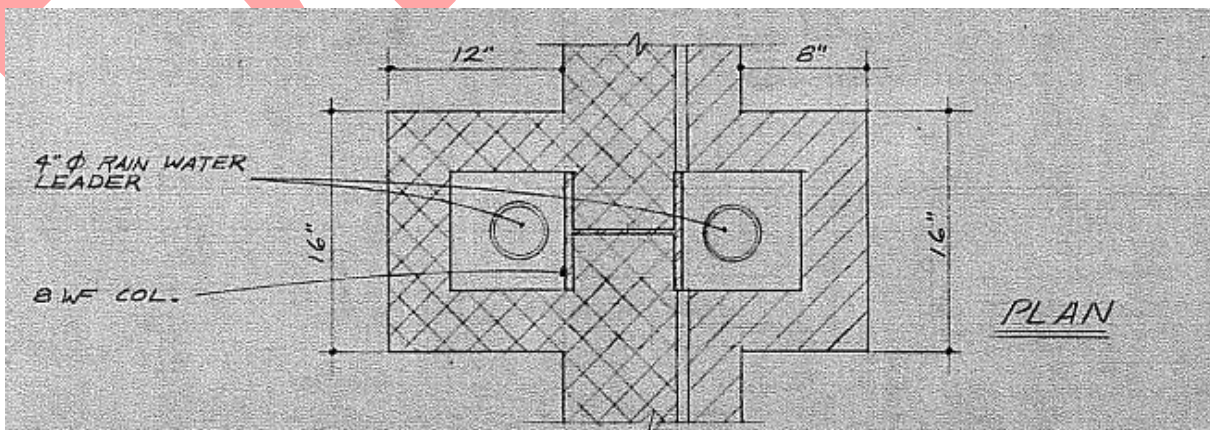
Figure 9: Plan view of chase section at the Cafeteria. Detail taken from 2/12 of the 1968 Drawings.

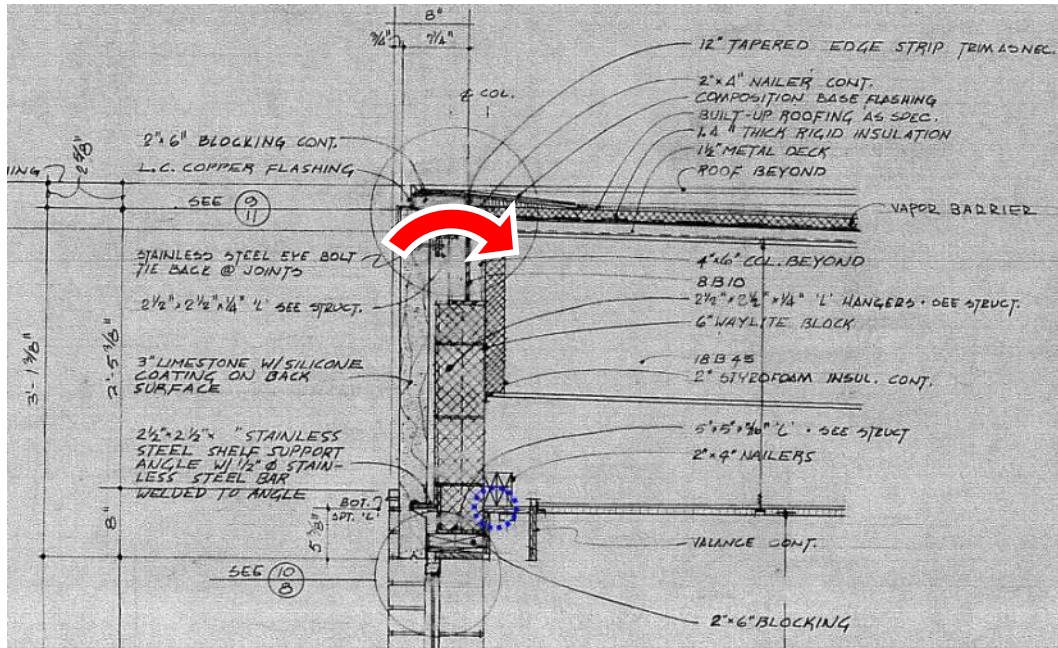
Figure 11: Typical window/wall section detail. Detail taken from 2/12 of the 1968 Drawings. Point of air infiltration during smoke testing indicated by blue dashed circle.

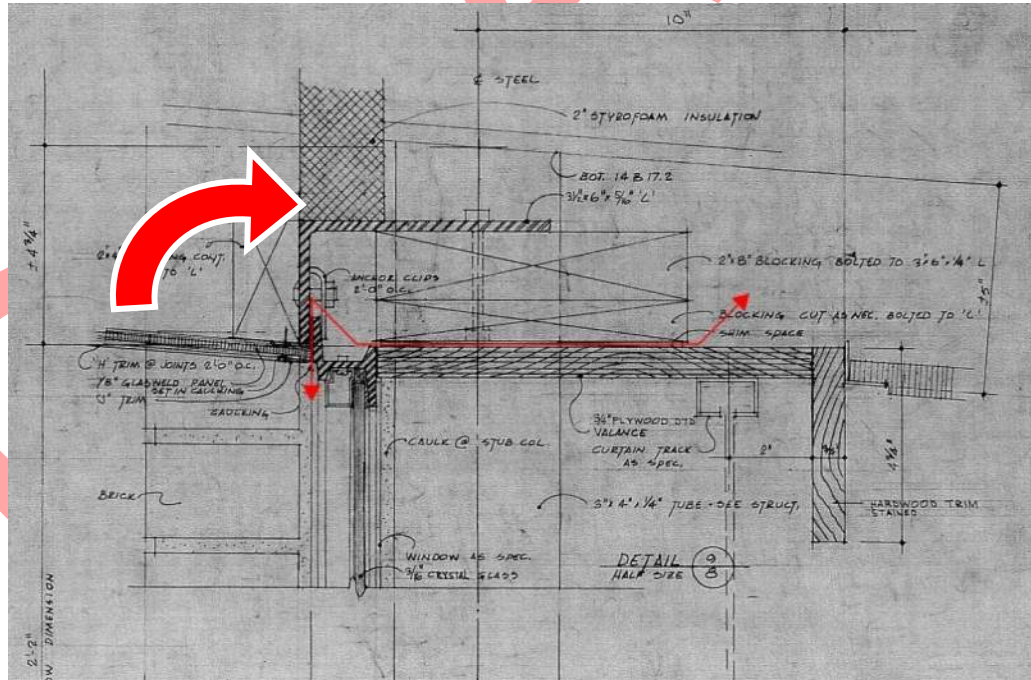
Figure 12: Typical window head section detail. Detail taken from 9/8 of the 1968 Drawings. Arrow indicating potential air infiltration path.

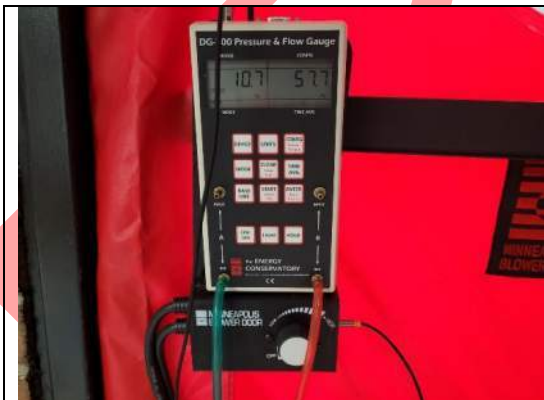
Image 63 – View of testing pressure applied within Rooms 26 and 22 during testing. Approximately 11 Pa of positive pressure was applied using one (1) blower door fan.

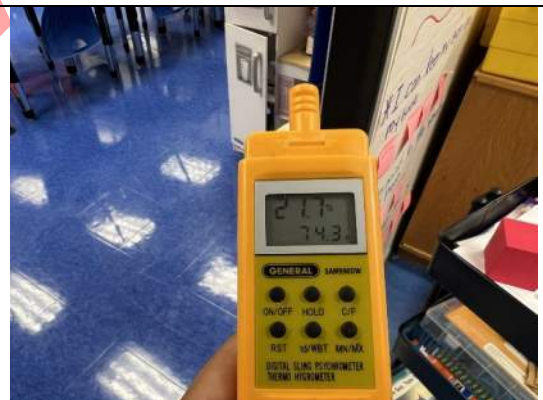
Image 64 – View of relative humidity during testing at Rooms 26 and 22. Approximately 21.7% relative humidity shown.

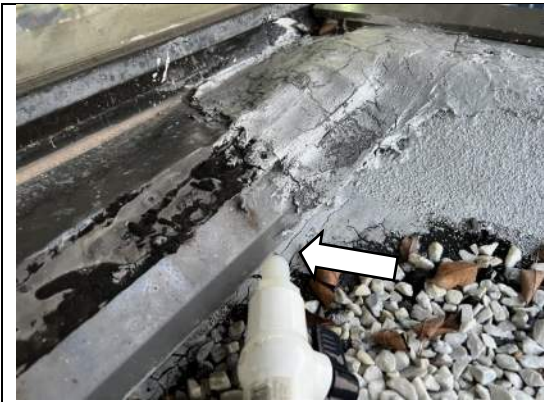
Image 65, Negative Pressure – View of smoke infiltration testing in progress at the exterior. Note: Smoke observed at interior when applied to base of flashing beneath lead-coated copper sill flashing.

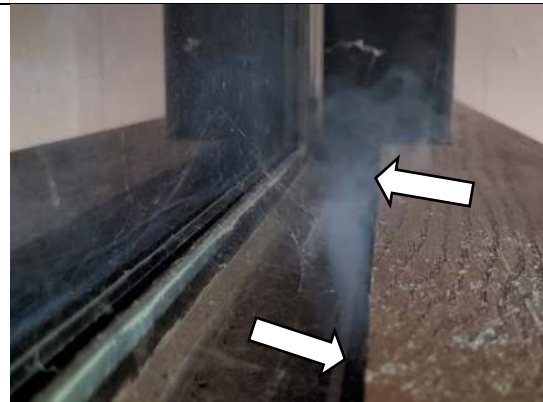
Image 66, Negative Pressure – Representative view of smoke infiltrating between the existing condensate gutter and stool, indicated by arrows.

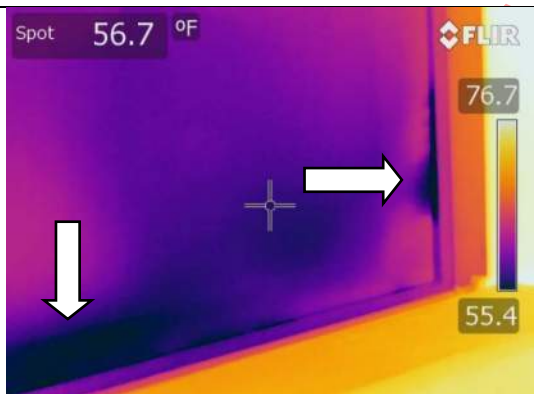
Image 67, Negative – Evidence of air infiltration observed at the jamb of the window sash.

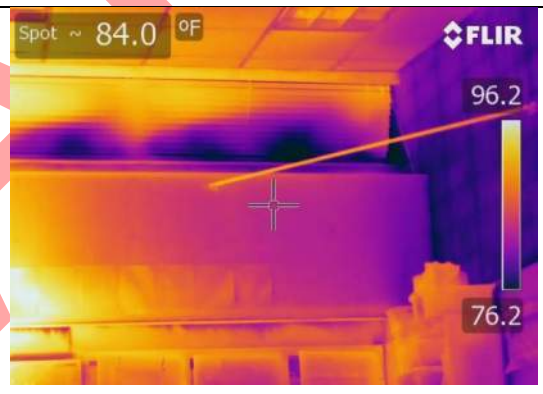
Image 68, Negative – Evidence of air infiltration observed at the sill of the clerestory windows.

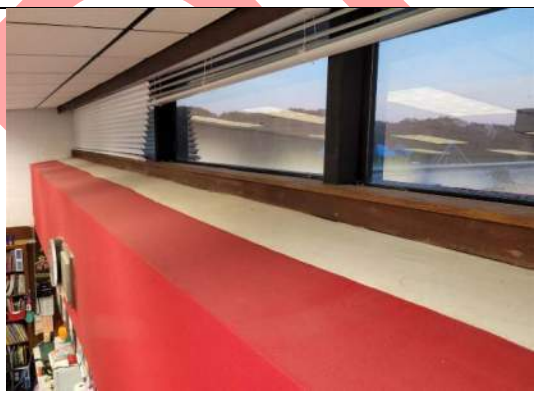
Image 69 – Interior view of the bulkhead located beneath the clerestory windows in the Pod Classrooms.

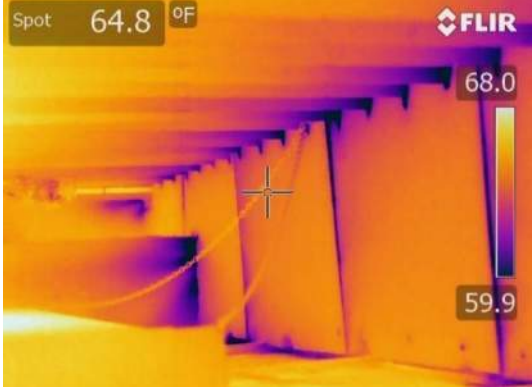
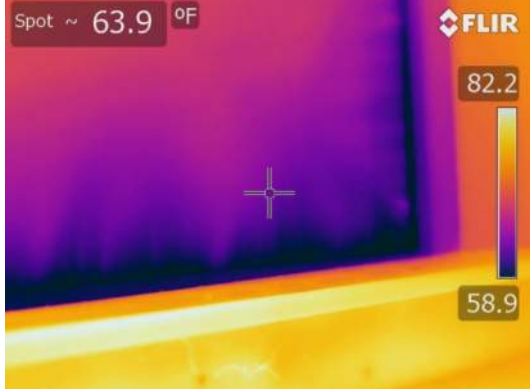
<p>Image 81, Negative Pressure – Infrared images showing evidence of air infiltration occurring around the EPS insulation infill.</p>	<p>Image 82, Negative Pressure – Infrared image showing evidence of air infiltration at window sash perimeters.</p>

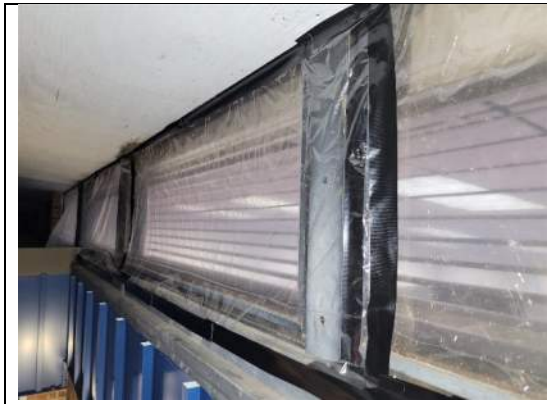
Image 83 – Plastic sheeting was install to provide temporary isolation to suspected air leakage source paths.

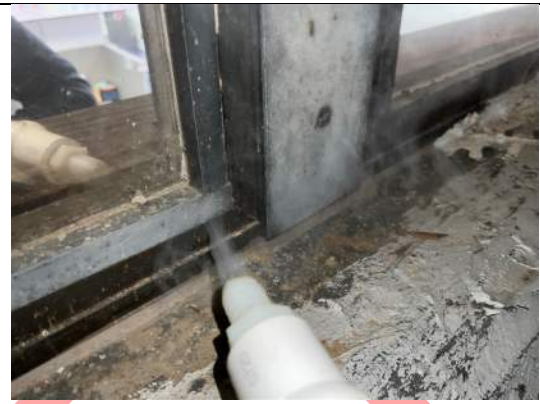
Image 84 – Tracer smoke observed being drawn into the building through the clerestory window frame.

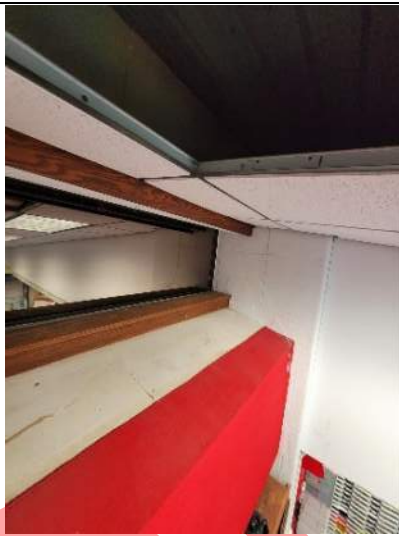
Image 85 – Partial view of the area within Room 7 where access to the pier wall and soffit condition were attained.

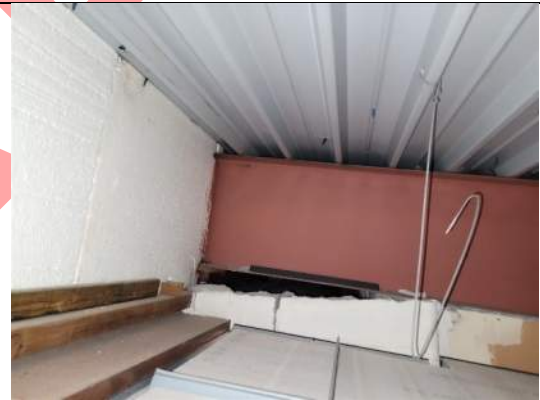
Image 86 – Gaps between the steel roof deck, the structural steel membrane, and the top of the pier wall can provide a path for air movement.

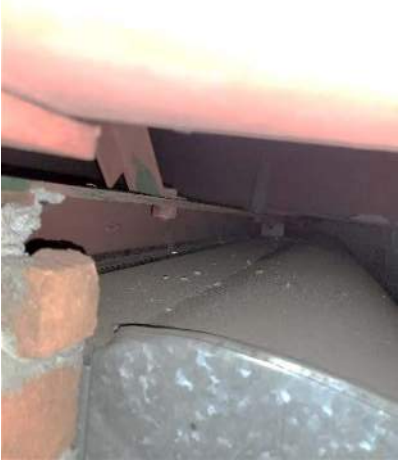
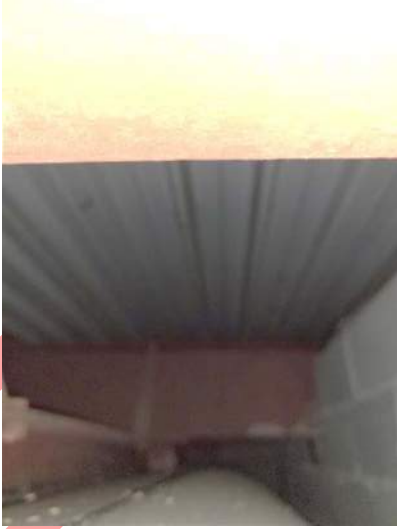
<p>Image 87 – Partial view into the pier wall that contains the HVAC ducts.</p>		<p>Image 88 – The pier wall space appears to provide connectivity between interior spaces through the roof deck flutes and over the top of partition walls.</p>

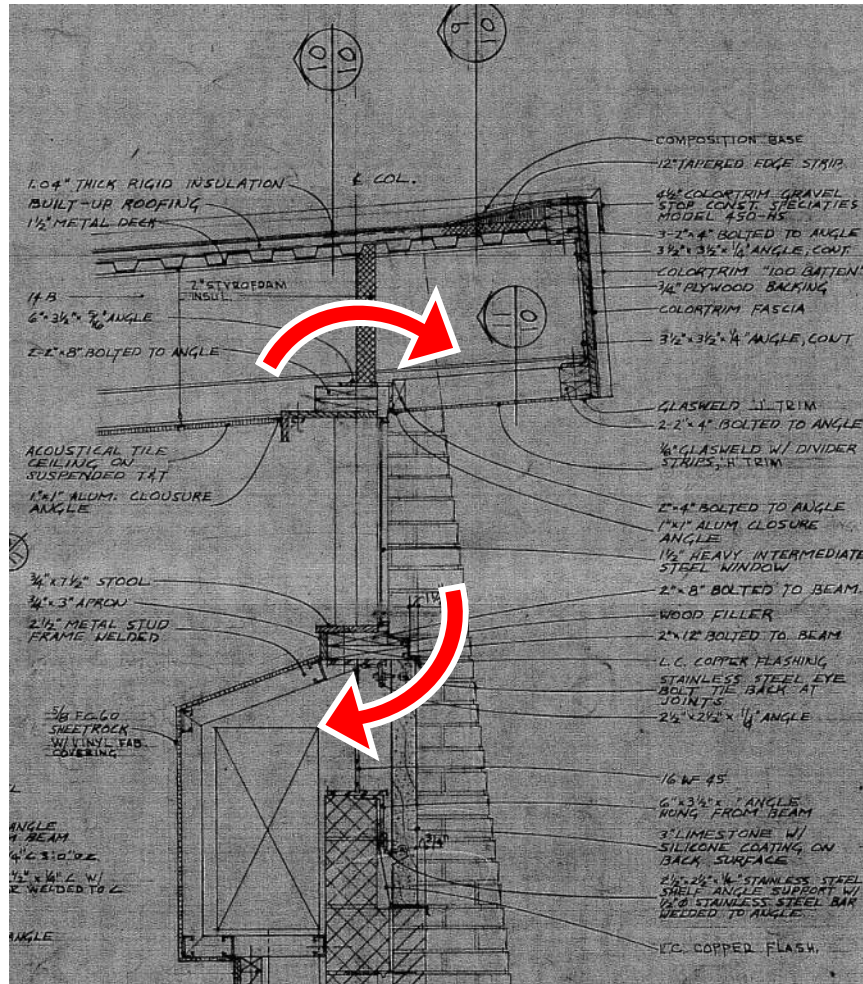
Figure 13: Exterior facing wall section at Room 26. Section referenced from Detail 5/10 of the 1968 Drawings.

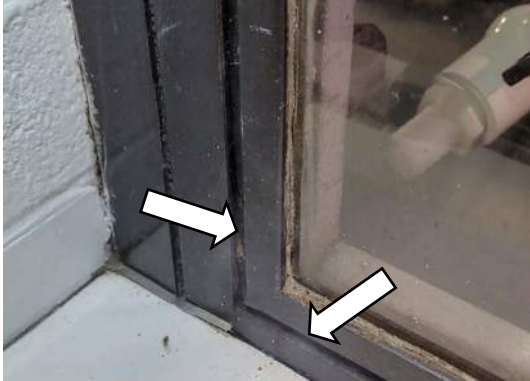
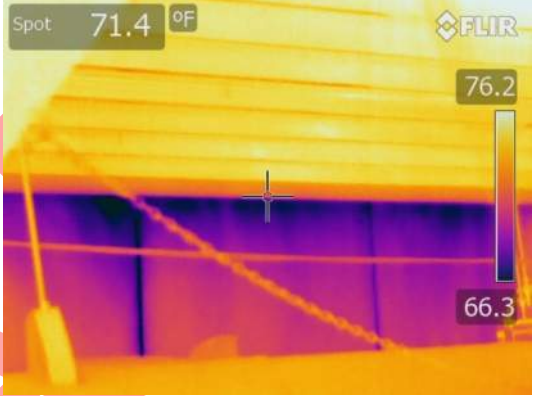
<p>Image 91, Negative Pressure – View of smoke infiltration testing at the interior in progress. Smoke was observed to infiltrate between window frame and sash indicated by arrows.</p>	<p>Image 92, Negative Pressure – Infrared image of roof deck-to-wall interface located above the dropped ceiling in Room 18. Thermal anomalies appear at the transition between the roof deck and the EPS insulation infills.</p>

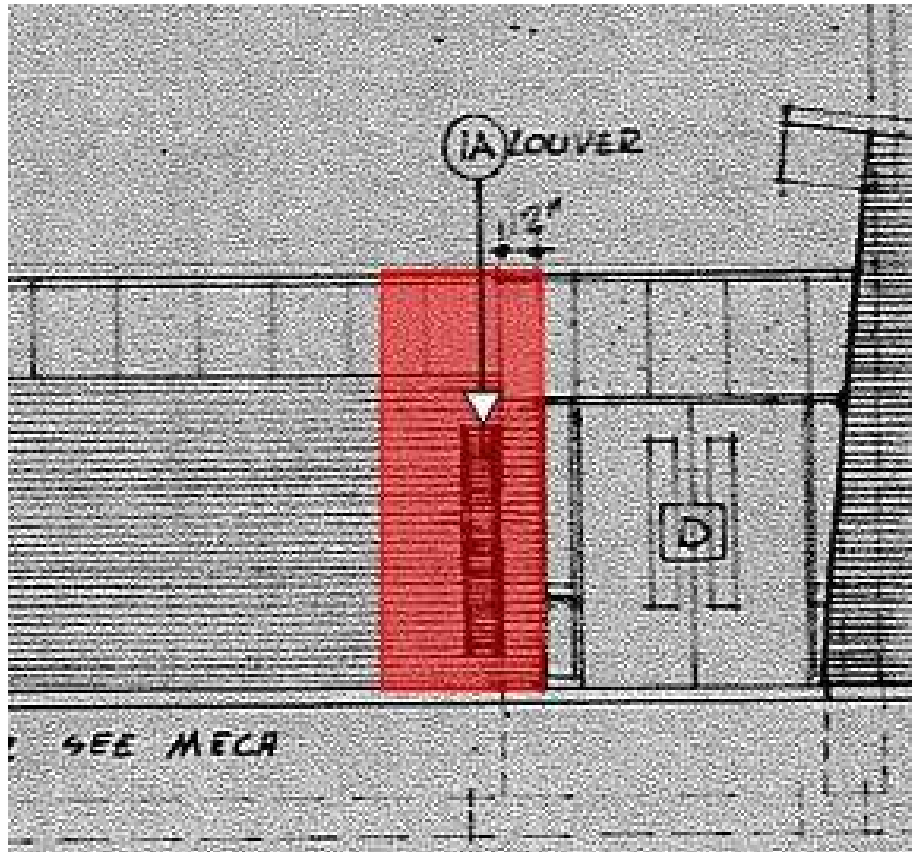
Figure 16: Exterior elevation between Rooms D and E. The approximate area of masonry pier indicated by red shaded area.

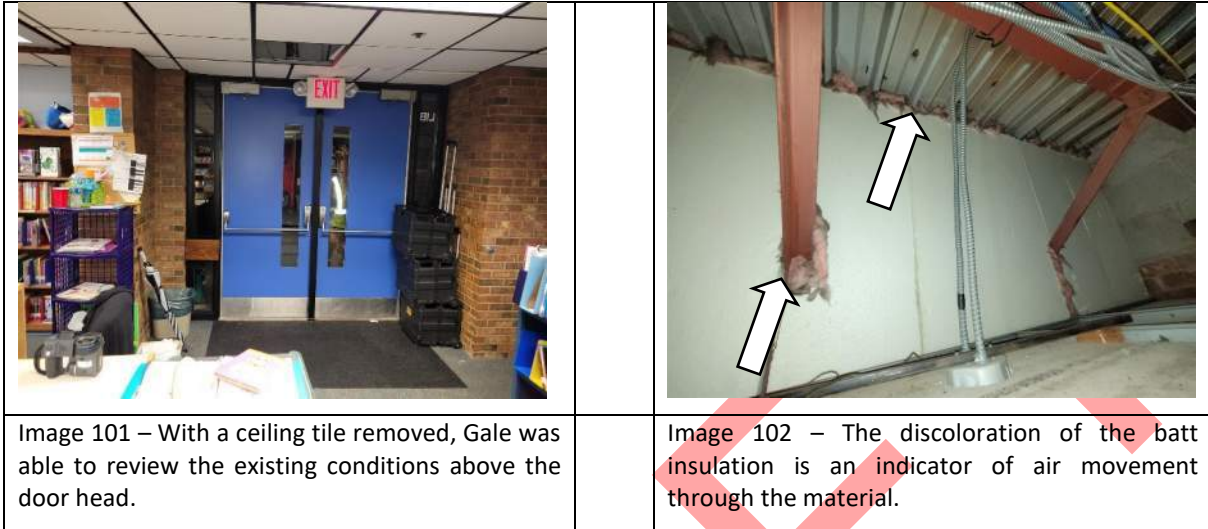
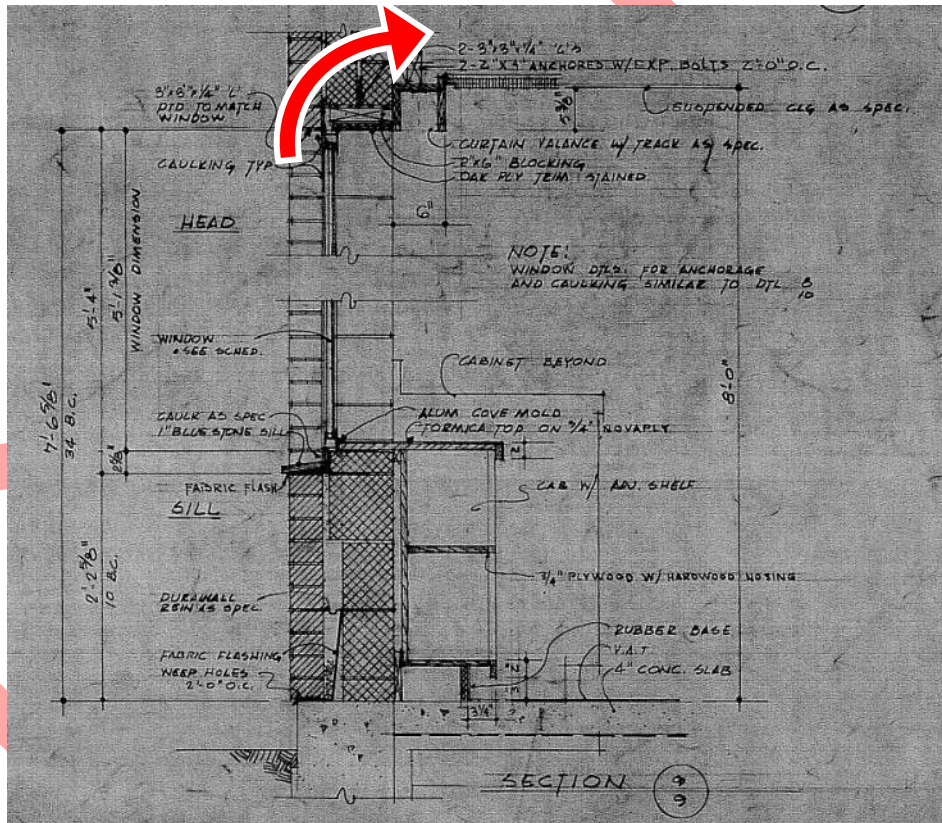
Figure 17: Wall section at office area between Rooms D and C. Section referenced from Detail 9/9 of the 1968 Drawings.

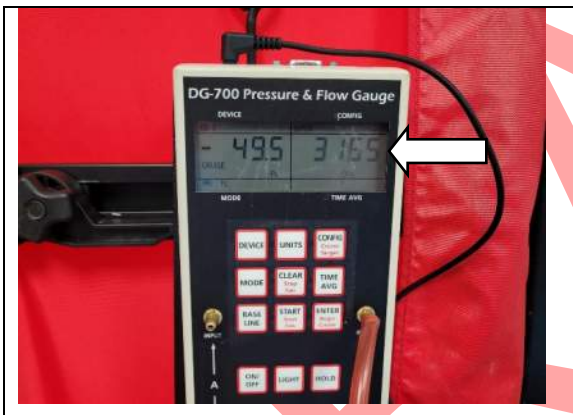
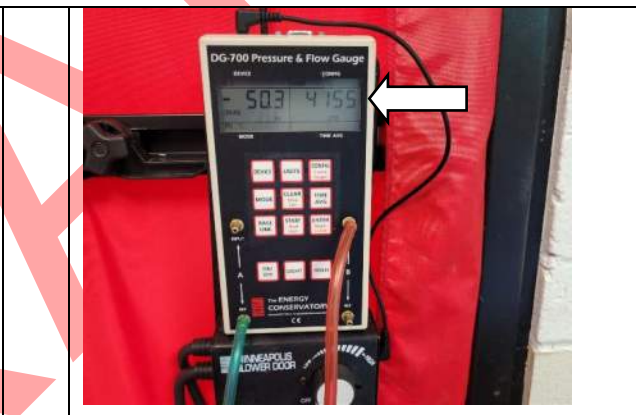
<p>Image 107 – With isolation sheeting <u>installed</u>, an air flow rate of 3165 CFM is required to create a - 50 Pa pressure difference within the classroom space.</p>	<p>Image 108 – With isolation sheeting <u>removed</u>, an air flow rate of 4155 CFM is required to create a - 50 Pa pressure difference within the classroom space.</p>

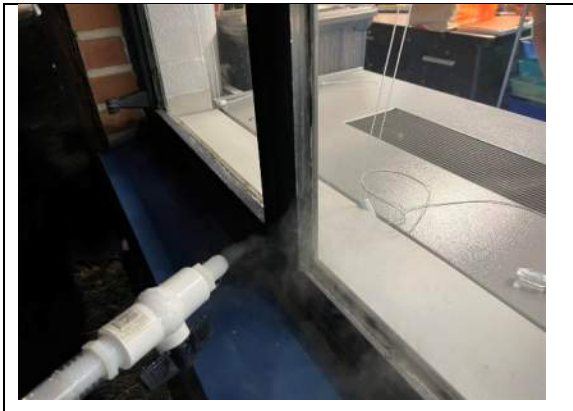
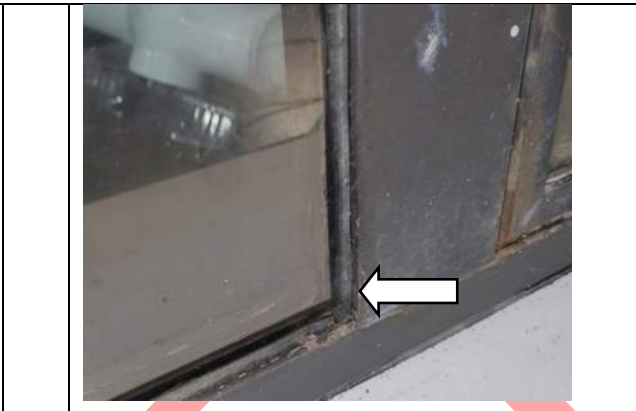
<p>Image 109, Negative Pressure – Smoke tracer testing directed at the windowsill.</p>	<p>Image 110, Negative Pressure – Smoke tracer observed passing through the window sash-to-frame transition.</p>

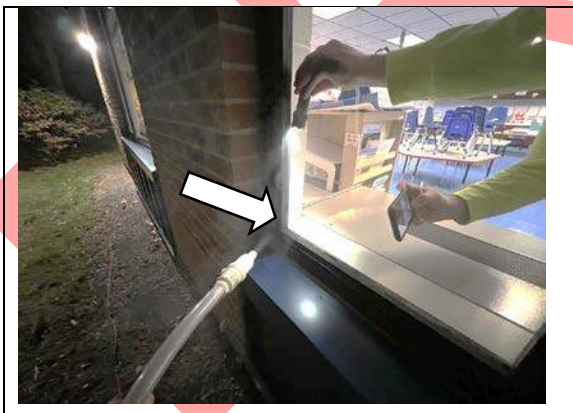
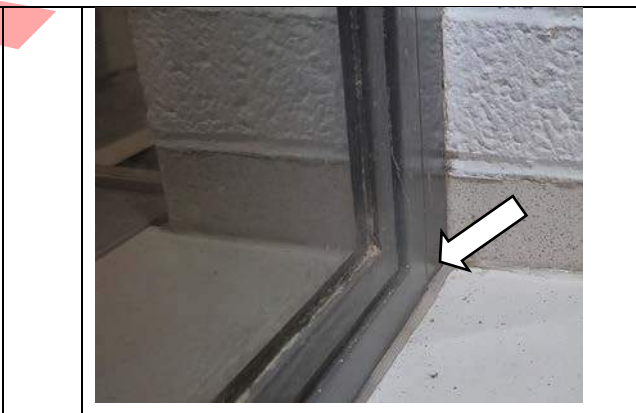
<p>Image 111, Negative Pressure – View of smoke trace testing in progress at the exterior. Smoke observed infiltrating at the interior during application of smoke along sill.</p>	<p>Image 112, Negative Pressure – Smoke observed infiltrating between window sash and frame, observation typical along the sill and corners of windows at the sill level.</p>

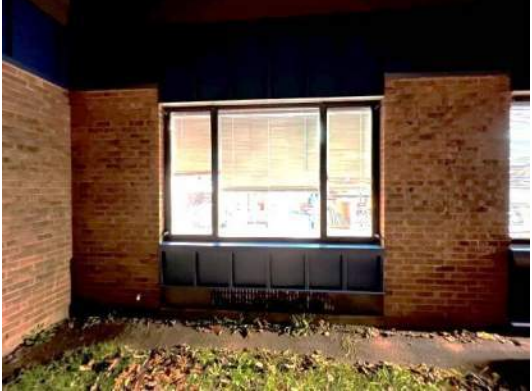
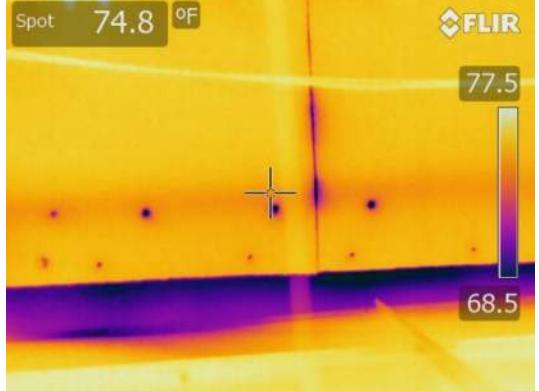
<p>Image 117 – Exterior view of a window assembly within Room 30. Light from the interior could be seen shining through the louvers.</p>	<p>Image 118, Negative Pressure – Thermal anomalies occurring around the perimeter of the EPS insulation infills at the roof deck and between board sections.</p>
