February 2017

Windsor

Windsor Recreation and Leisure Services
Town of Windsor, CT
599 Matianuck Ave
Windsor, Connecticut 06095

ENGINEER'S REPORT

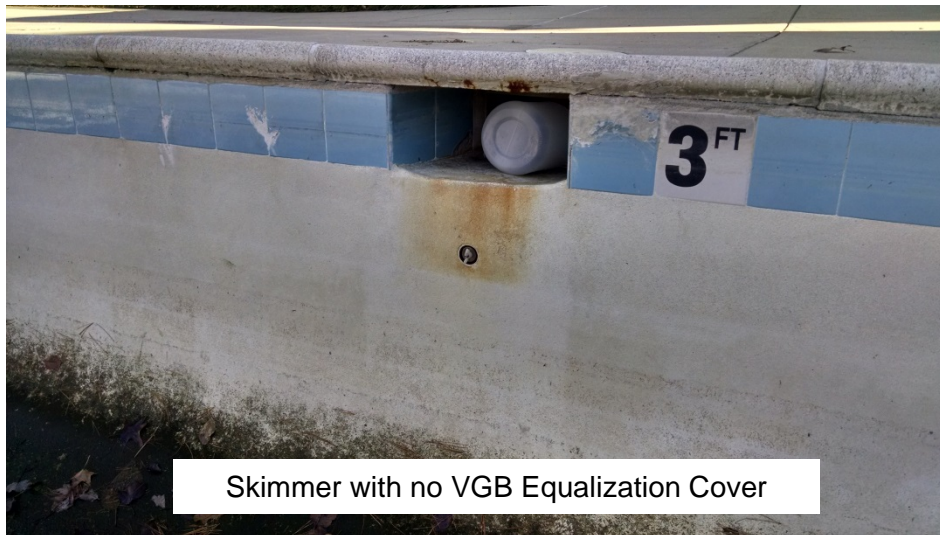
VGB rated covers are not found on the equalization lines. In accordance with VGB code, these covers must be installed on all skimmer equalization lines.

Anti-entrapment devices shall be installed on the skimmer equalization lines. We recommend purchasing a VGB equalization cover that can be installed onto the wall with concrete anchors. The cover shall be rated for 50 GPM at 1.5 FPS

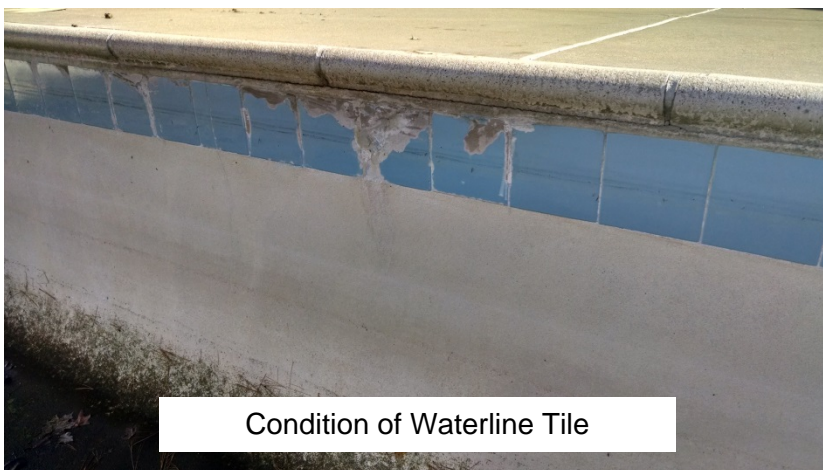
Condition of Waterline Tile

The perimeter waterline tile is in poor condition. The tile has failed and cracked in numerous locations. It appears the failure has been caused by water infiltrating behind the tile and creating a freeze thaw cycle. The cracked and failing water line tile is abrasive and a hazard to bathers.

The existing waterline tile shall be removed and replaced with new freeze resistant water line tile. The old mortar shall be removed and chipped to original concrete. The tile shall be set with an

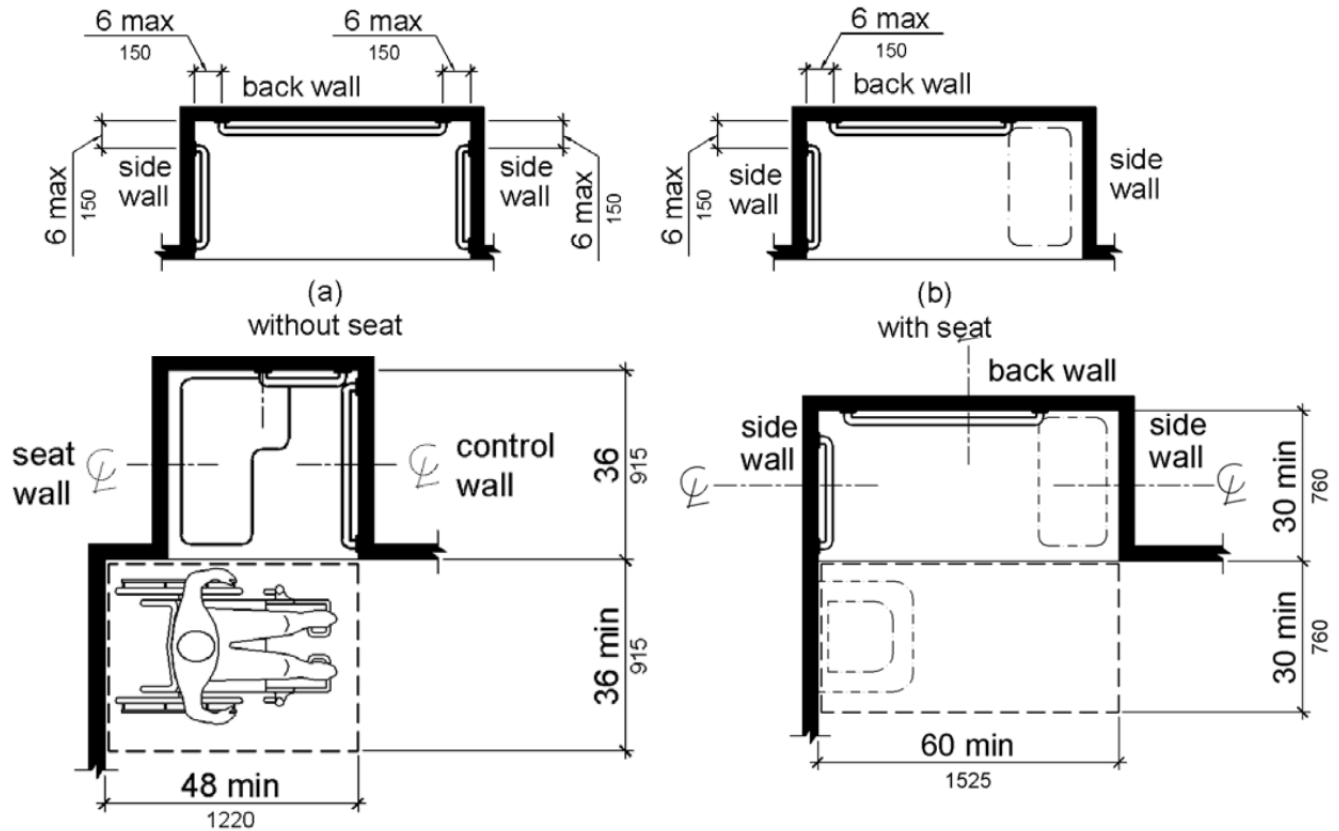
The current ADA showers do not have a spray unit with a 59 inch long hose, and the current stalls do no provide hot water to the bather. Tempered water is required for an ADA shower.

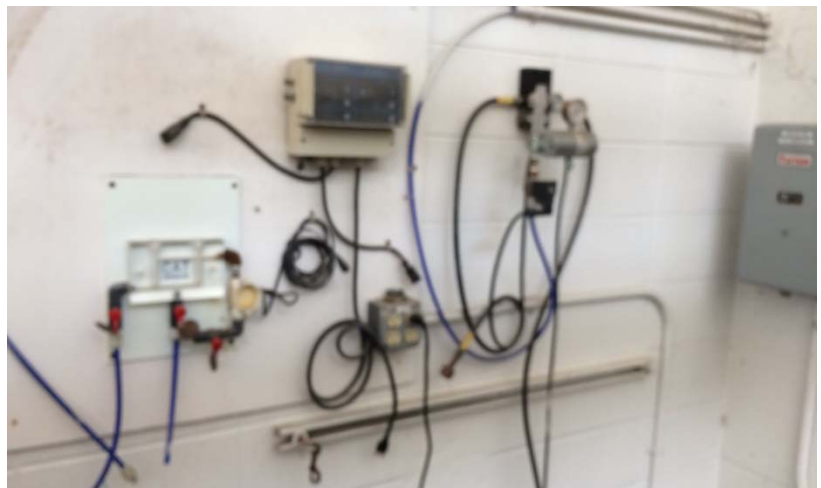
Abandoned Chemical Controllers

The chemical controllers found on site are not operational. The pool chemistry is maintained manually by the facility staff. This is a time intensive process, and can lead to inconsistencies in water chemistry.

- Chemical Feed System – It is strongly recommended a chemical controller to be installed on the system which would operate a sodium hypochlorite metering pump, (removing the Trichlor System), and a CO2 injection system to maintain water chemistry.

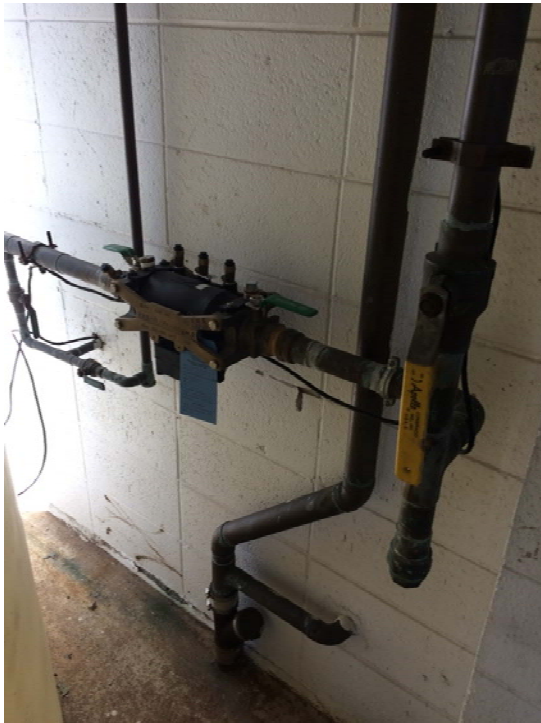
Water Feed to Wading Pool

No air gap was found on the fill line to the pools as the pools are directly connected to a public water source.

- Air Gap – An auto fill line would need to be installed under the pool deck from the equipment room to the water's edge. A PVC probe unit can be installed in the deck housing the water sensor with fresh water attached in the equipment area. Another option would be to install a route to a collector tank, located in the grassy area between the wading pool and filter area.
- Pressure Gauges – A vacuum gauge and pressure gauge shall be located on the piping system.
- Piping – Due to UV deterioration, the pipe solvent welds should be evaluated. At a

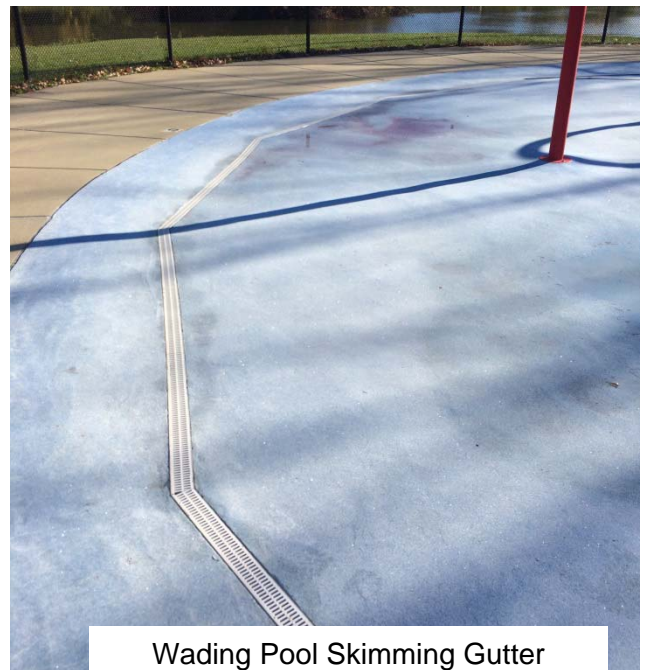
The gutter on the zero entry portion of the pool is not properly designed. The trough has no discharge pipe and fills with scum and algae and is a health hazard. The biological growth will hamper proper water

chemistry in the pool. It is recommended the existing gutter be removed and replaced with a concrete trough or fiberglass gutter trough with PVC fiberglass grating. The grating shall be a minimum of 1 FT wide. The trough would drain to a proposed collector tank found in the grassy area between the wading pool and the filter system.

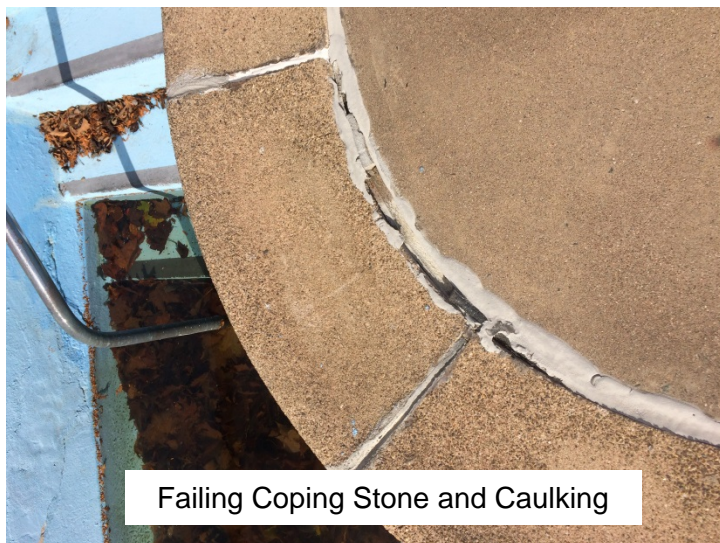
Failing Coping Stone and Caulking

In sound testing, approximately all the coping stones are loose or have separated to the point if someone stepped on them they would fall into the pool. They are a fall / trip hazard.

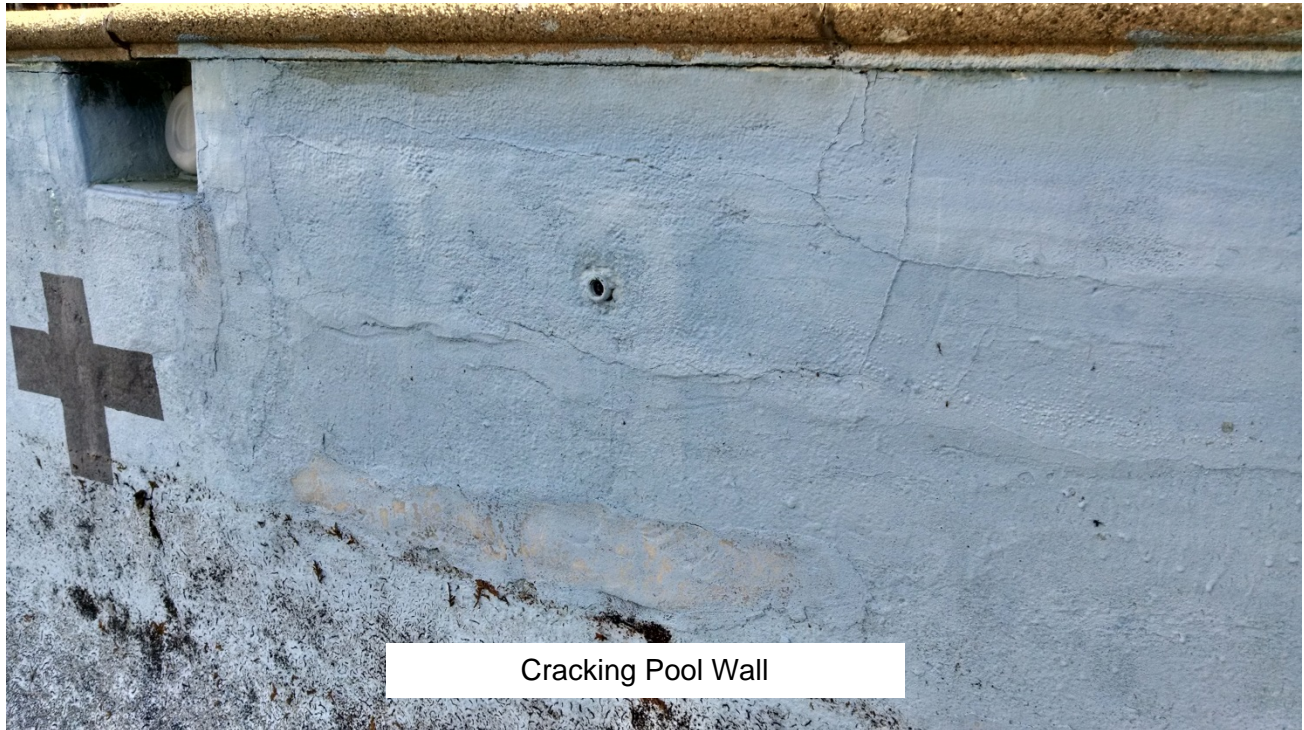
The pool has numerous cracks and is starting to spall in locations. During non-destructive sound testing large voids were found behind the pool wall surface and pool deck. More than likely the pools plumbing lines are compromised and have been eroding soil below the slab and structure for years. This has likely resulted in freeze / thaw cycles breaking down the wall and deck.

Also, over 50 years of chlorinated water have most likely infiltrated through the concrete possibly corroding the rebar compromising the structural shell integrity.

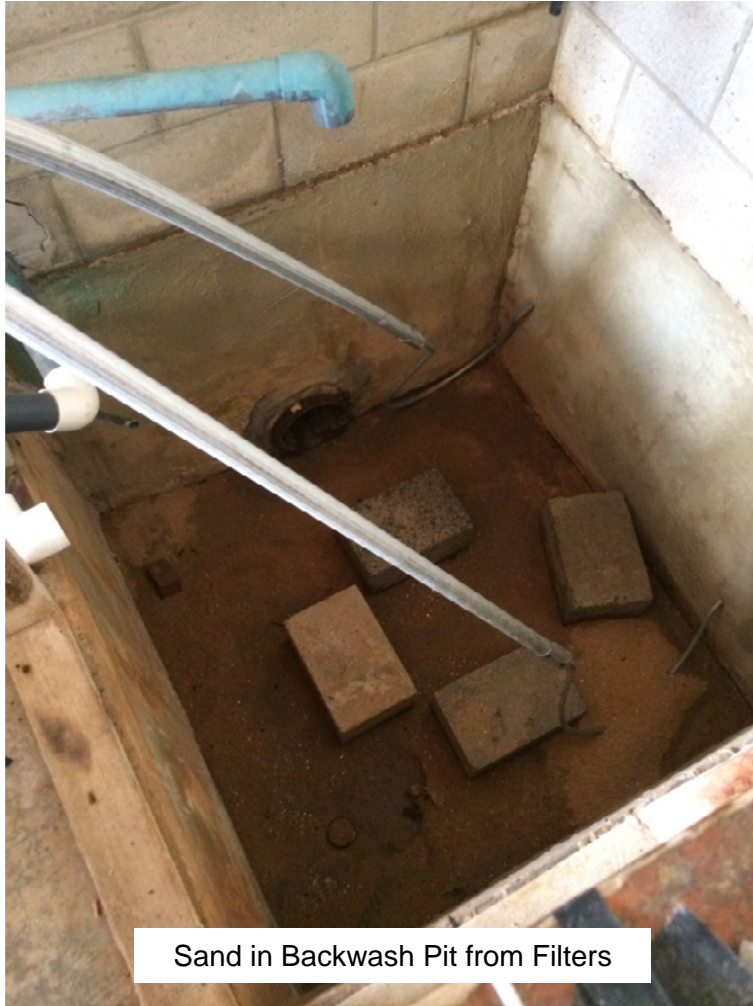
Sand in Backwash Pit from Filters

Operators have noted the multiport valves are stripped and the laterals are broken because they are flushing sand out of the filter every time they backwash. There is a question as to how much
