Lead-Based Paint Abatement Plan

**39 Warham Street
Windsor, CT**

**Town of Windsor Housing
Rehabilitation Loan Program
Windsor Connecticut**

RE: Lead Based Paint Abatement Plan
39 Warham St., Windsor, CT
EnviroPlan Project No. 2019-152-11

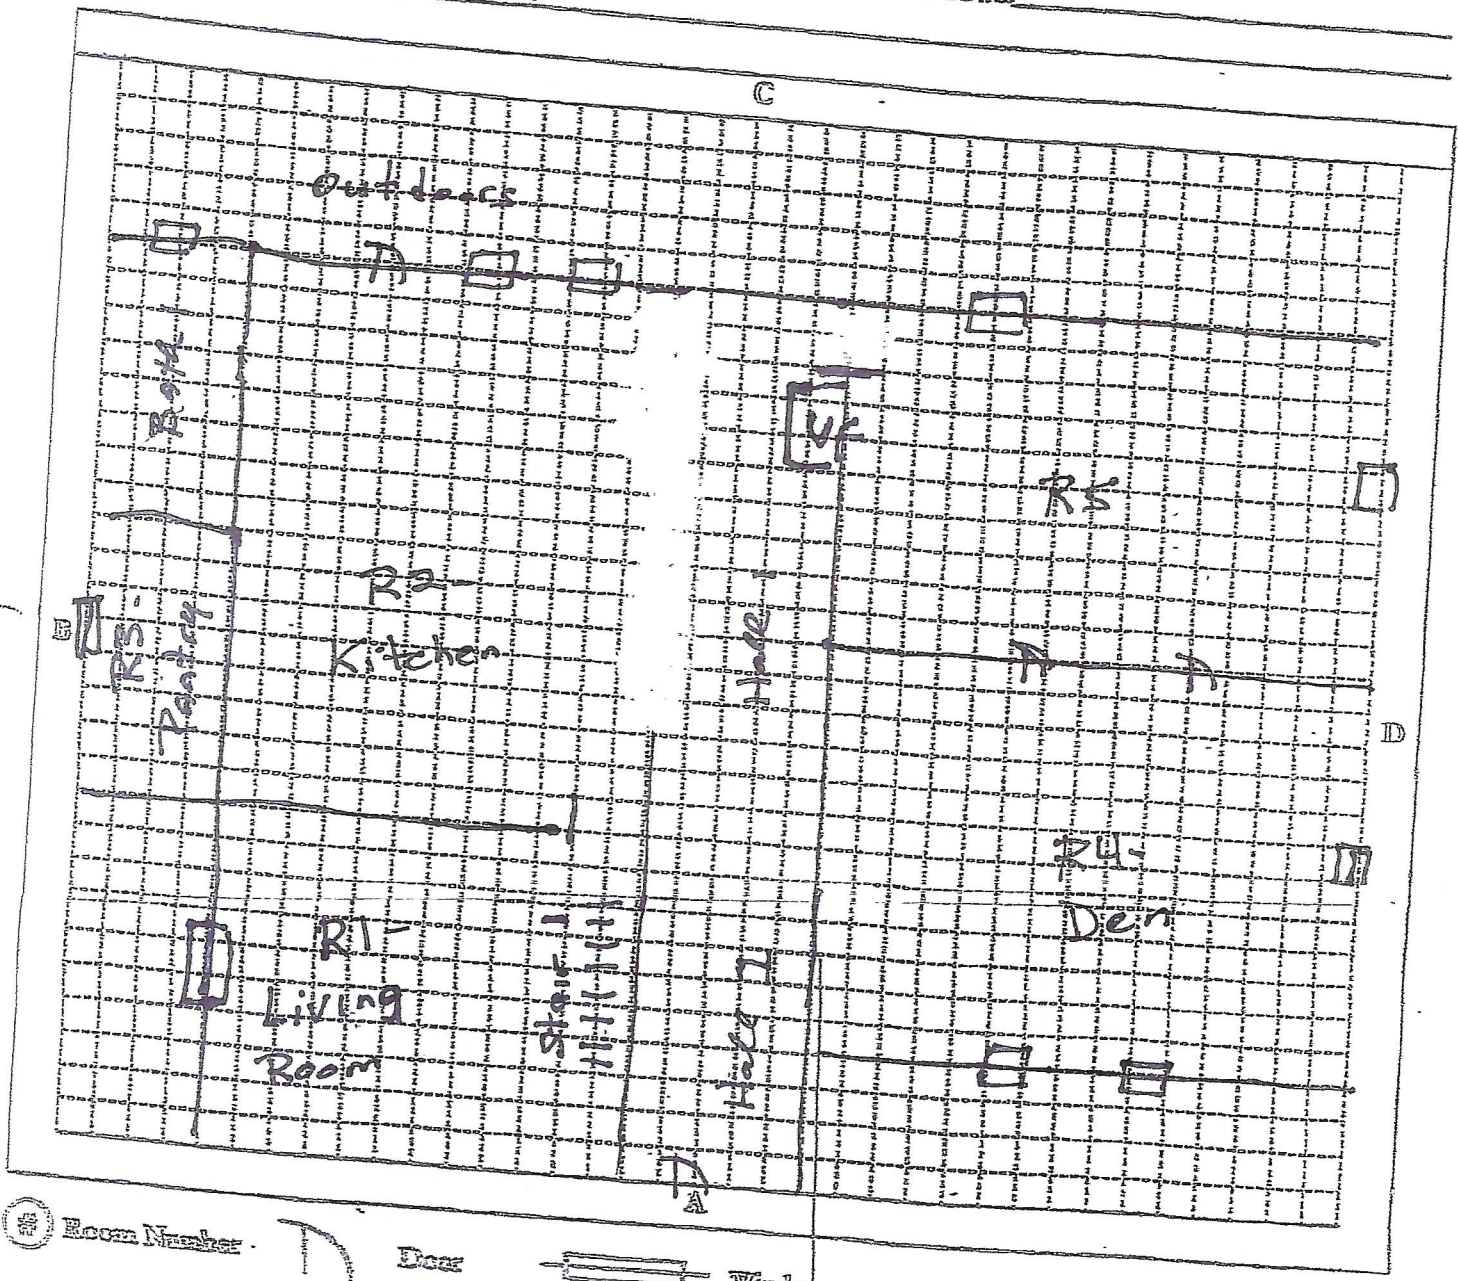
Diagram of Floor 1 No. of Windows: _____

LOCATION	COMPONENT	CONDITION	REMEDATION METHOD
INTERIOR			
FIRST FLOOR			
R3-Pantry	Baseboards	Defective	Provide removal of any areas of loose flaking paint and prepare surfaces for liquid encapsulation, Provide interior liquid encapsulant approved for use in the State of Connecticut. Color of encapsulant to be approved by the homeowner
R3-Pantry	A-D Walls	Defective	Provide removal of any areas of loose flaking paint and prepare surfaces for liquid encapsulation, Provide interior liquid encapsulant approved for use in the State of Connecticut. Color of encapsulant to be approved by the homeowner
R3-Pantry	B Window Trim and Sill	Defective	Provide removal of any areas of loose flaking paint and prepare surfaces for liquid encapsulation, Provide interior liquid encapsulant approved for use in the State of Connecticut. Color of encapsulant to be approved by the homeowner
R3-Pantry	D Side Casing (in Cased Opening)	Defective	Provide removal of any areas of loose flaking paint and prepare surfaces for liquid encapsulation, Provide interior liquid encapsulant approved for use in the State of Connecticut. Color of encapsulant to be approved by the homeowner

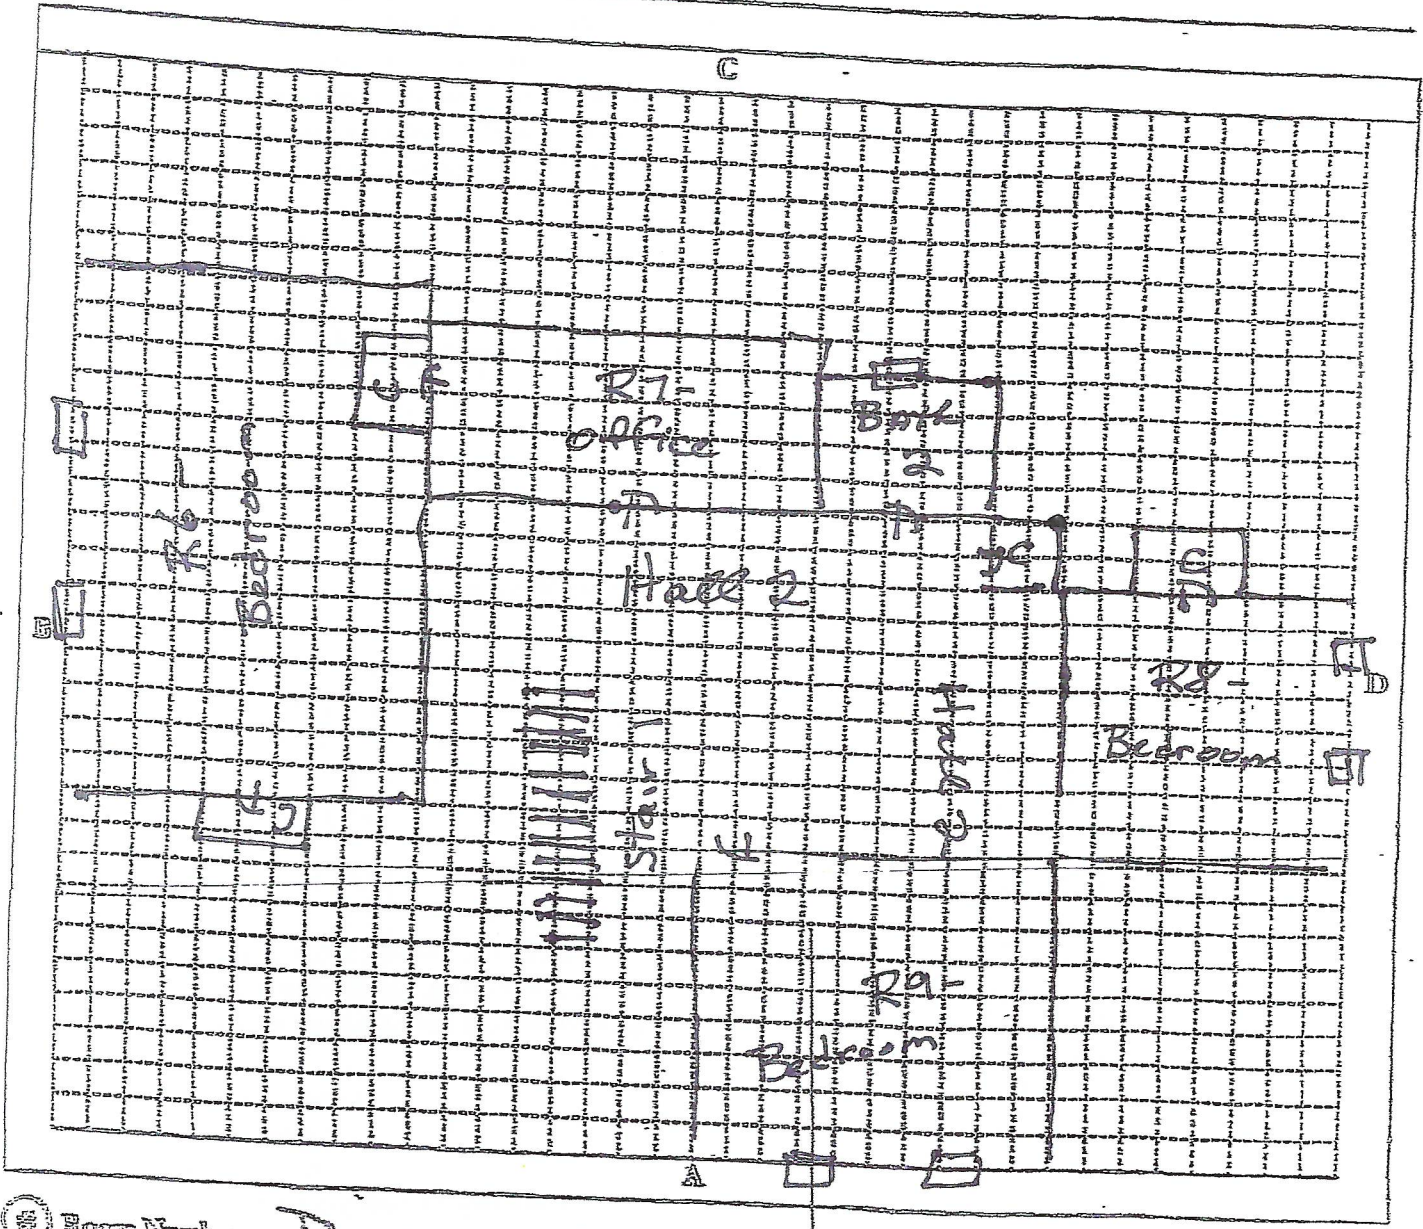
Diagram of: Floor 2

SECOND FLOOR			
R-7-Office	B and C Walls (Wainscoting)	Defective	Provide removal of any areas of loose flaking paint and prepare surfaces for liquid encapsulation, Provide interior liquid encapsulant approved for use in the State of Connecticut. Color of encapsulant to be approved by the homeowner

LOCATION	COMPONENT	CONDITION	REMEDIATION METHOD
INTERIOR			
SECOND FLOOR			
R-7-Office	Ceiling (Wainscoting)	Defective	<p>Provide removal of any areas of loose flaking paint and prepare surfaces for liquid encapsulation,</p> <p>Provide interior liquid encapsulant approved for use in the State of Connecticut. Color of encapsulant to be approved by the homeowner</p>
R-7-Office	B Door (to Closet)	Defective	<p>Option 1:</p> <p>Scrape door edges to bare substrate using wet methods.</p> <p>Provide removal of any areas of loose flaking paint on the remainder of the door which is not a friction or impact surface and prepare surfaces for liquid encapsulation.</p> <p>Provide interior liquid encapsulant approved for use in the State of Connecticut. Color of encapsulant to be approved by the homeowner</p> <p>Option 2:</p> <p>Door to be removed and replaced with new door in accordance with the rehabilitation specifications of the Windsor Housing Rehabilitation Loan Program.</p> <p>Dispose of the door as presumed hazardous waste unless a TCLP test characterizes the total amount of waste generated in the project as non-hazardous or the homeowner is willing to take possession of debris in writing if the total amount of waste falls within the State of Connecticut 10 cubic yard homeowner exemption.</p>

LOCATION	COMPONENT	CONDITION	REMEDIATION METHOD
INTERIOR			
SECOND FLOOR			
R-7 Office	Window Sills (rear half covered and not lead hazard but the front portion exposed and significantly damaged and a lead hazard)	Defective	Provide removal of any areas of loose flaking paint and prepare surfaces for liquid encapsulation, Provide interior liquid encapsulant approved for use in the State of Connecticut. Color of encapsulant to be approved by the homeowner
EXTERIOR-HOUSE			
Side A	Clapboard Siding	Defective	Provide removal of any areas of loose flaking paint and prepare surfaces for liquid encapsulation, Provide exterior liquid encapsulant approved for use in the State of Connecticut. Color of encapsulant to be approved by the homeowner
Side A	Upper Trim	Defective	Provide removal of any areas of loose flaking paint and prepare surfaces for liquid encapsulation, Provide exterior liquid encapsulant approved for use in the State of Connecticut. Color of encapsulant to be approved by the homeowner

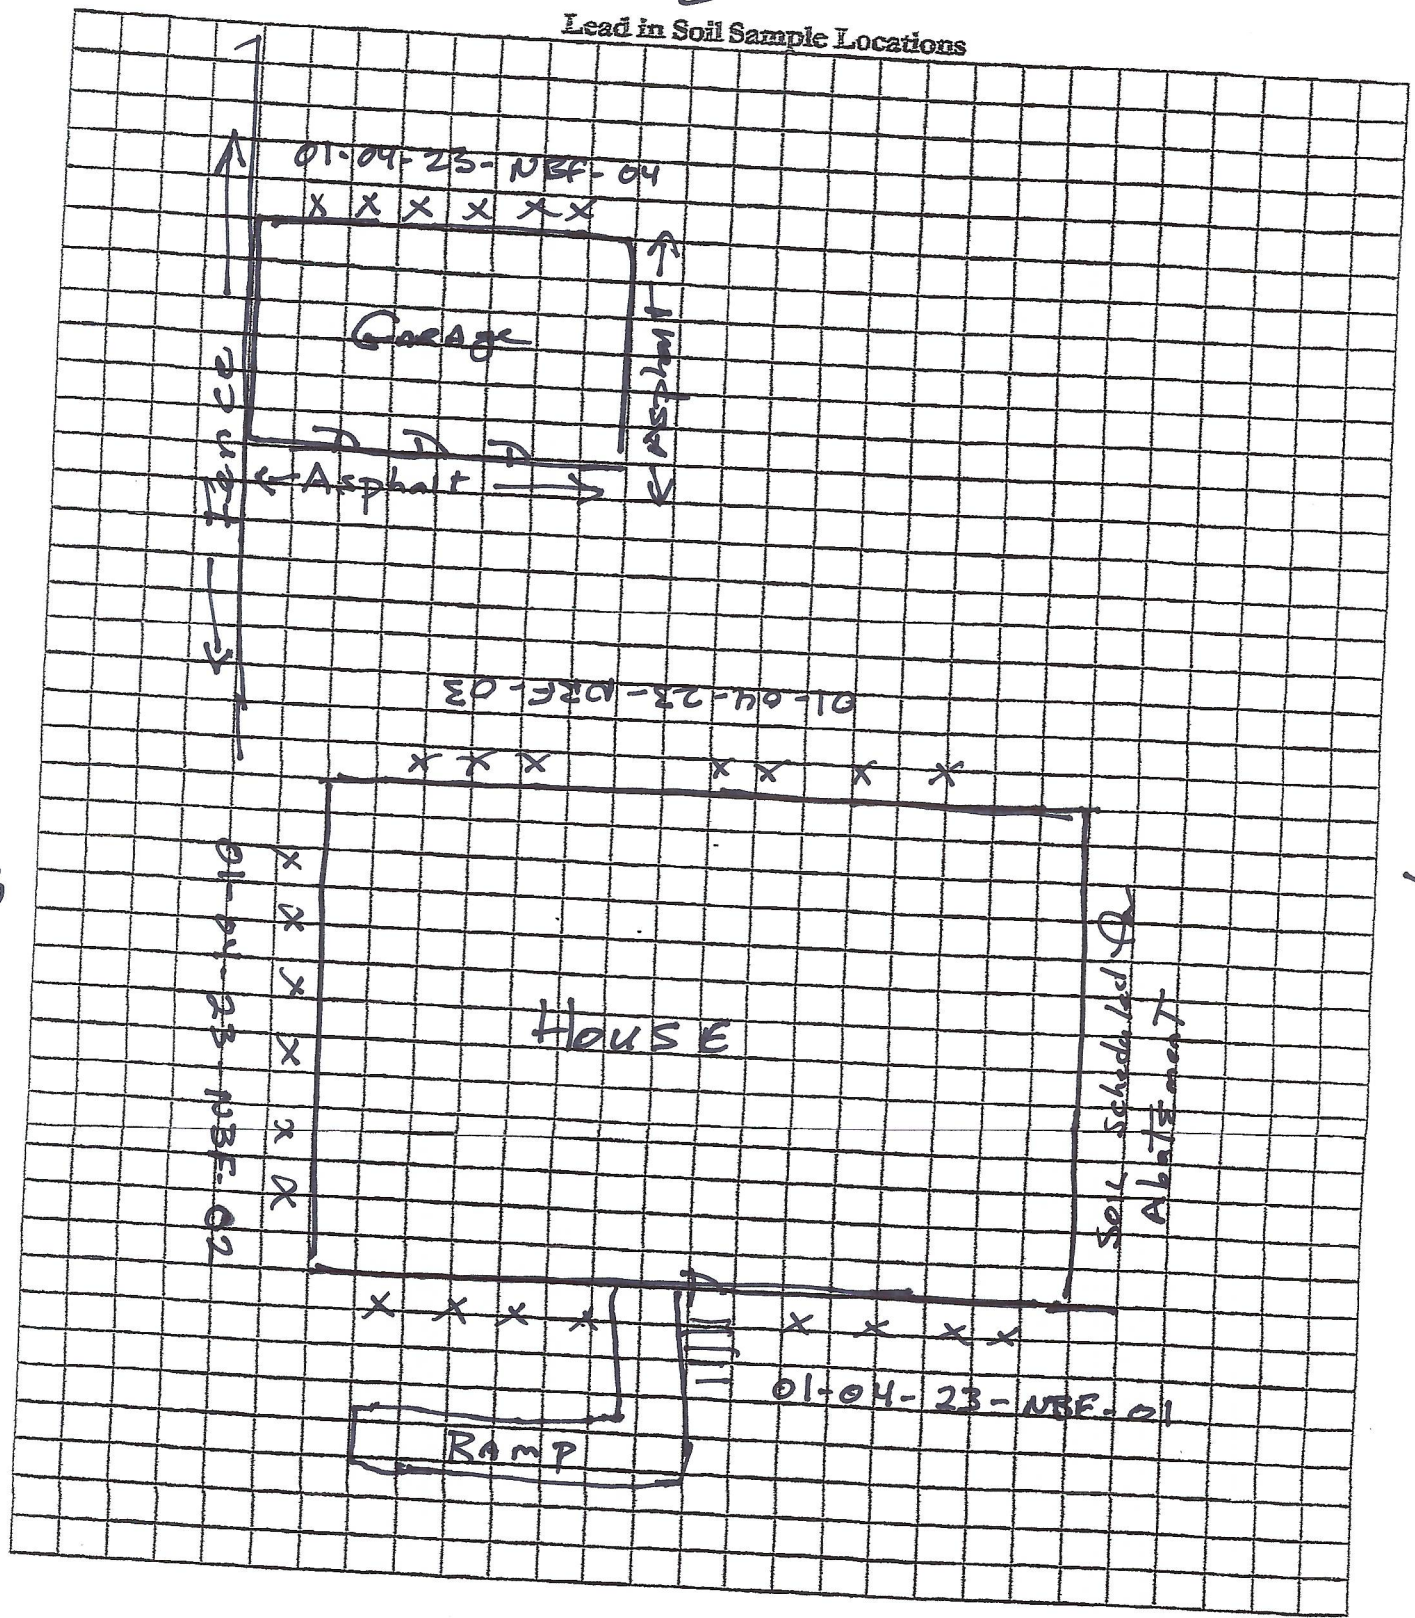
C
Lead in Soil Sample Locations

8. Baseline soil samples were collected in the aforementioned locations on January 4, 2023. The result in the **A dripline** was 2500 mg/kg. To put this into perspective, when the soil in the dripline on that side of the house was sampled during the LIRA, the level of lead was only 140 mg/kg, well below the CTDPH threshold of 400 mg/kg. A result below 400 mg/kg is considered to be non-lead hazardous. The question is why did the baseline sample have such a high lead result? One possibility is that the weatherization contractor did not use the requisite lead safe work practices, following the EPA RRP Rule's containment requirements, and the soil was contaminated during the removal of the windows.

The result in the **B dripline** was 1500 mg/kg and, therefore, the soil in that area is also a lead hazard. This area was not sampled in the LIRA.

The result in the **C dripline** was 2400 mg/kg and, therefore, the soil in that area is also a lead hazard. This area was not sampled in the LIRA.

The baseline sample collected from the C side of the garage had a result of 310 mg/kg and, therefore, the soil in that location **was not** found to be a lead hazard.

9. These baseline results on the A, B and C sides of the house require that the abatement plan include soil remediation on those sides. An interim control method can be used as the results are below 5,000 mg/kg. On the C side of the garage, upon the conclusion of exterior abatement, to confirm that the contractor utilized methods to protect the soil in that location, a confirmatory soil sample will be collected to determine if the lead in soil levels have remained below 400 mg/kg.
