February 2017

Windsor

Windsor Recreation and Leisure Services
Town of Windsor, CT
599 Matianuck Ave
Windsor, Connecticut 06095

ENGINEER'S REPORT

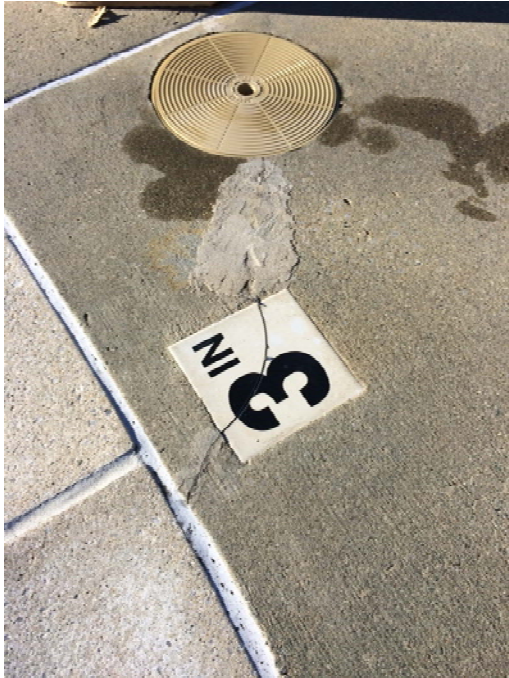
Issue

"No Diving" symbols are not present on the pool deck at locations where the depth is indicated. Any depth less than 5 feet should have this symbol installed.

As the pool was not in operation during the time of inspection, we recommend the water depth to be checked to ensure the pool water deck is correctly displayed on the deck and wall.

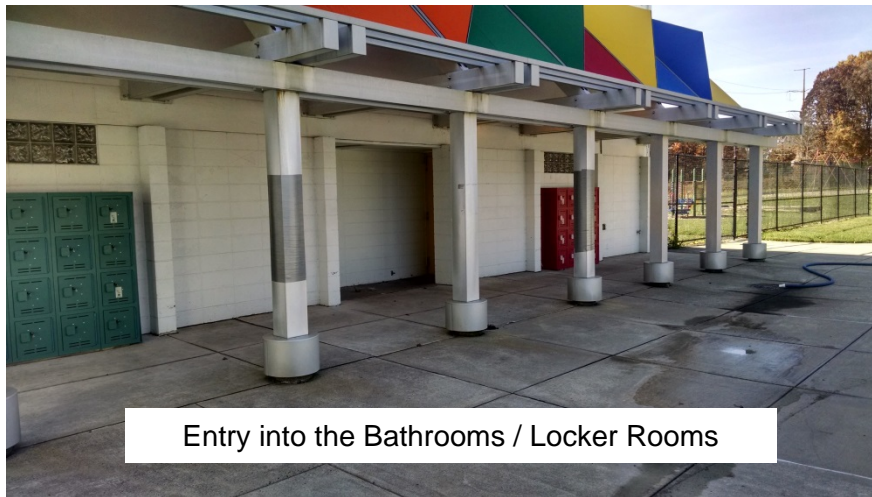
D. Flow of Traffic

In accordance with Connecticut Public Health Code 19 – 13 – B33b, (21.2) “Dressing Rooms, Toilets, and Showers – Bathhouses to be used simultaneously by both sexes shall be divided into two parts separated by a tight partition, each designated for men or women. The

entrances and exits shall be screened to break line of sight. The layout of the bathhouse should be such that the bathers on leaving the dressing room pass the toilets and showers en-route to the swimming pool.”

However, seeing that the bathhouse is deficient in the required amount of fixtures, this would be the opportunity to program the bath house to allow for a central entrance, adequate fixtures, and ADA access. A renovation of the bath house could address the ventilation, signage, ADA access, and sanitary requirements.

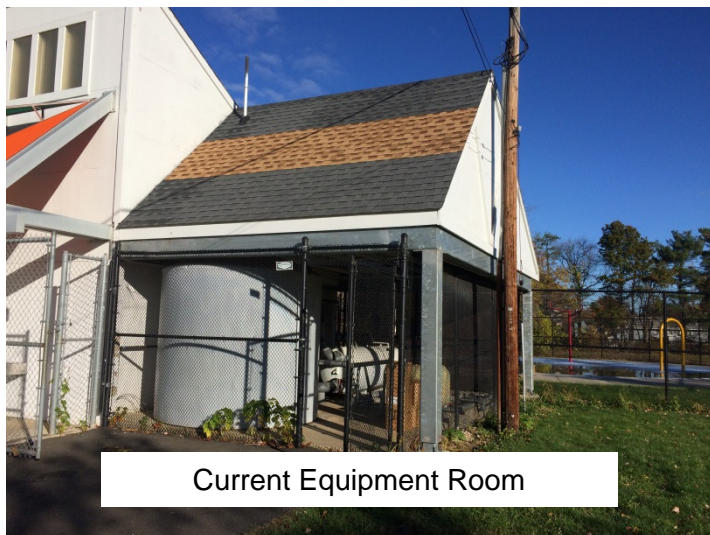
F. Equipment Protection

canopy top. This still leaves the equipment open to UV degradation, weathering and corrosion from blowing snow and rain.

Currently there is sodium hypochlorite stored in an un-ventilated space, with feed lines routed over electrical panels. The panels are showing signs of corrosion which could lead to an electrical failure or accident. Properly rated panels are required for this room or reconfiguration of the chlorine storage is needed.

It is recommended to permanently enclose the filter area portion of the site. The equipment has seen the effects of UV degradation and the harsh New England elements. Creating a permanent enclosure will result in extending the life span of the equipment.

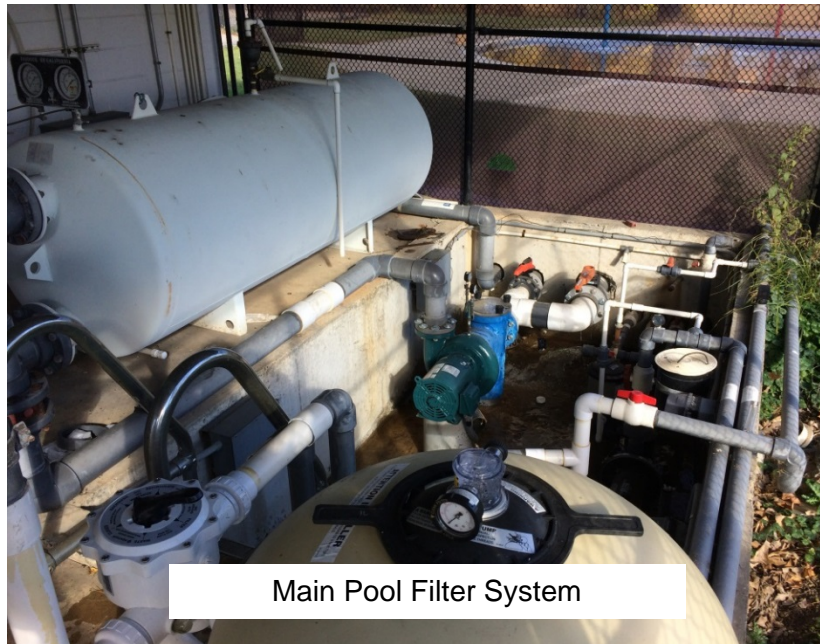
The main pool appears to have a new flooded suction pump. The sand filter appears to be original to the pool.

The current sand filter has aged and is starting to deteriorate. Manufacturers recommend a sand change every 6 to 8 years and it has been over 8 years since the last sand change. The filter appears to be original from the 1980's. There is concern over the condition of the steel filter as replacement seals and parts may no longer be available.

- Filter – At a minimum the sand to be changed. As this filter is approximately 30 years old, it may be in the Town's best interest to change the steel horizontal sand filter to a fiberglass horizontal sand filter.
- Piping – Due to UV deterioration, the pipe solvent welds should be evaluated. At a minimum the piping should be painted, labeled, and restrained.
- Chemical Feed System – It is strongly recommended that a chemical controller be installed on the system which would operate a sodium hypochlorite metering pump and a CO2 injection system to maintain water chemistry.

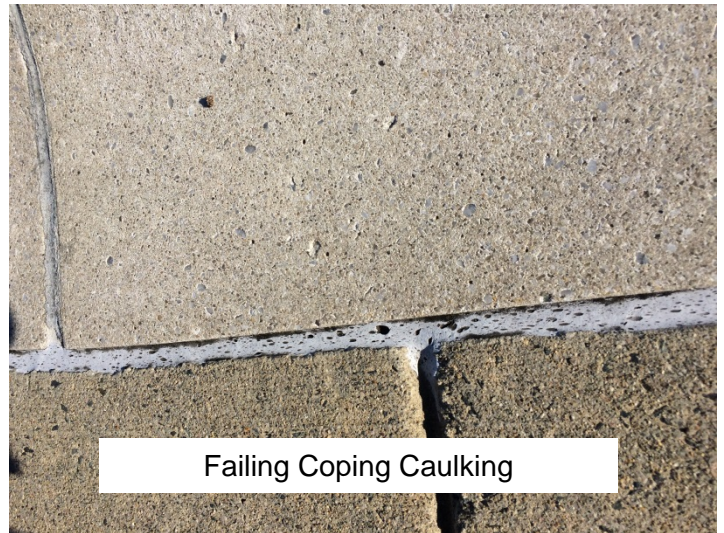
The caulk joint between the pool coping and the pool deck is failing, resulting in water infiltrating behind the coping stone and freeze / thaw cycles have dislodged various coping stones.

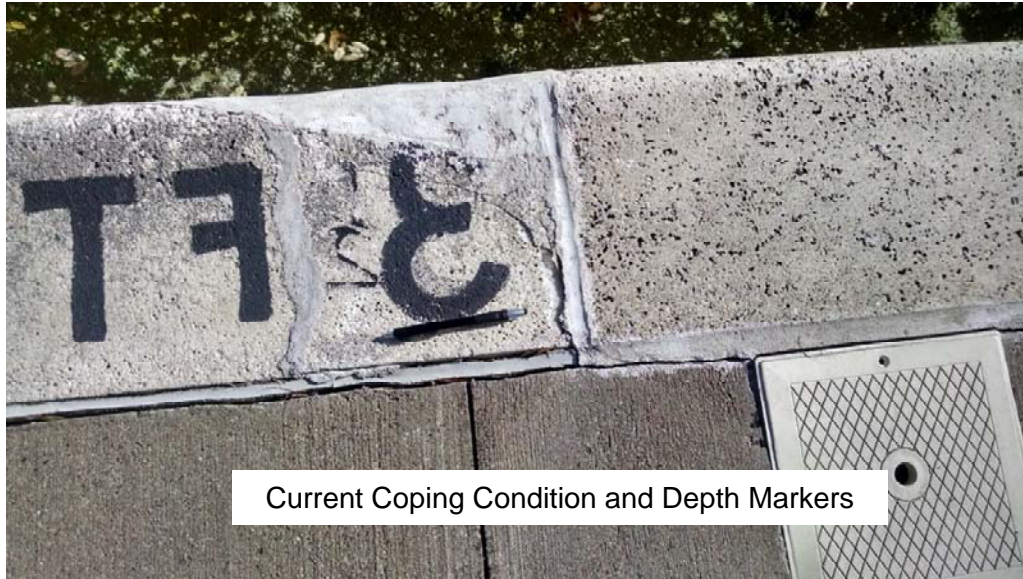
Issue

"No Diving" symbols are not present on the pool deck at locations where the depth is indicated. Where lettering is located the international symbol should be placed next to the lettering.

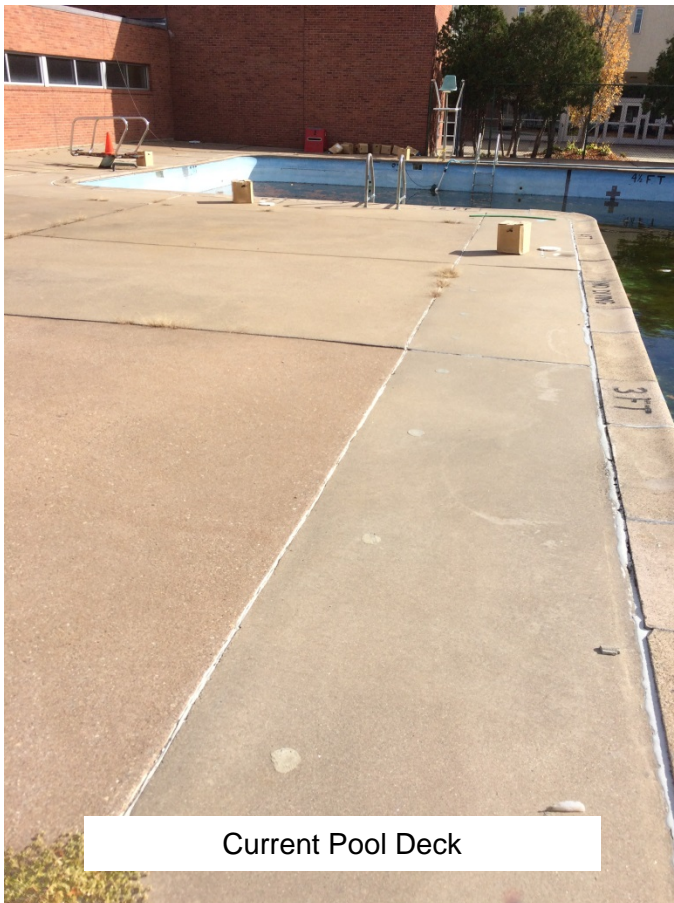
A. Pool Deck Slope

Issue

The current pool deck has lifted and heaved in many areas. The deck in some locations pitches back towards the pool creating pooling and standing water on the deck.

The pool deck is in poor condition. The various voids found under the deck during non-destructive sound testing and the current uneven surface has rendered it unsafe for patron use. The deck has exceeded its service life and should be replaced in conjunction with the pool.

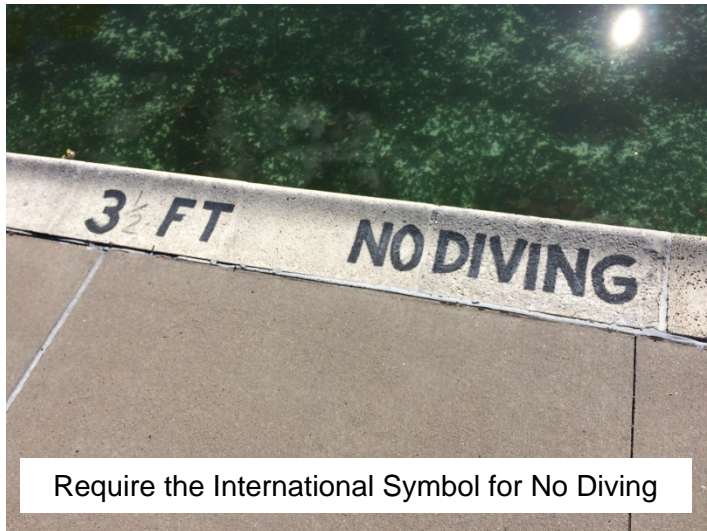
Issue

“No Diving” symbols are not present on the pool deck at locations where the depth is indicated. Where lettering is found the international symbol should be located next to the lettering.

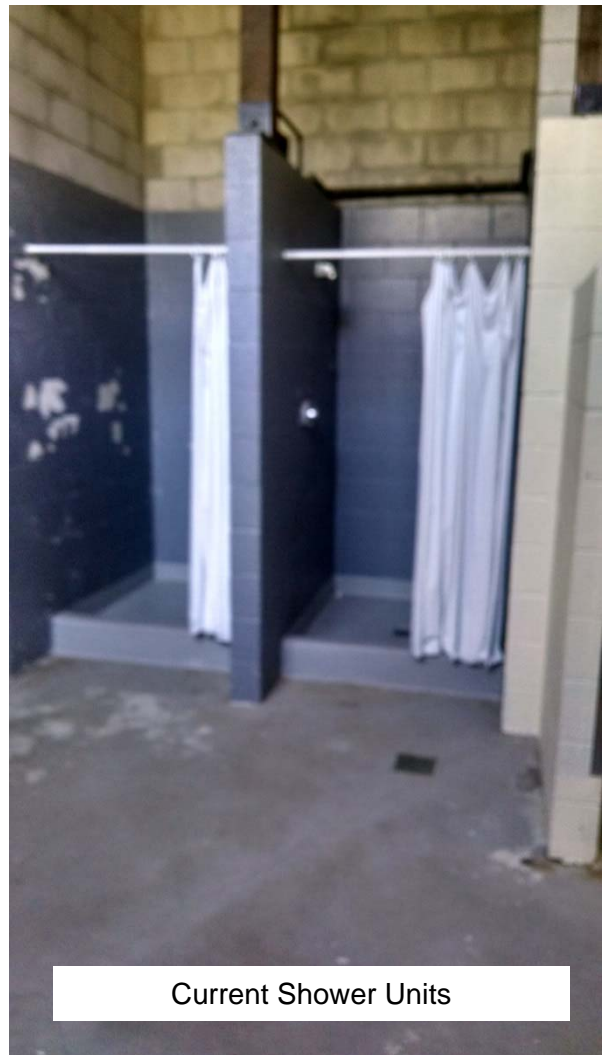
The step into the shower is approximately 6-inches, which is greater than 1/4" allowed by code.

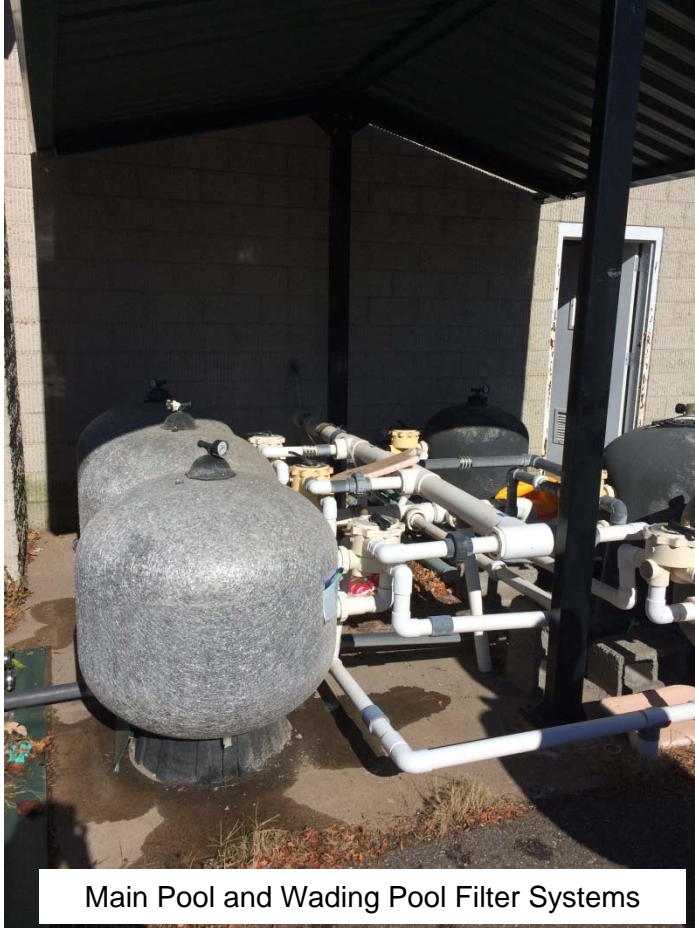
Main Pool and Wading Pool Filter Systems

Currently the filter equipment for both bodies of water are housed outside the facility with the filters housed under a canopy structure. This still leaves the equipment open to UV degradation, weathering and rusting from blowing snow and rain.

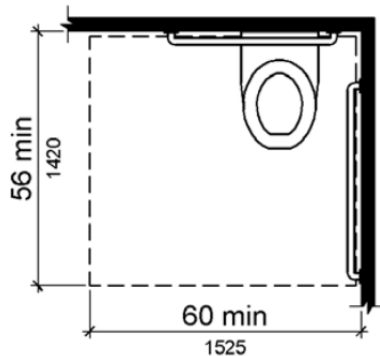
Currently on site there are no stalls that are ADA compliant. All stalls are less than 60" x 56" which is the minimum size for an ADA stall.

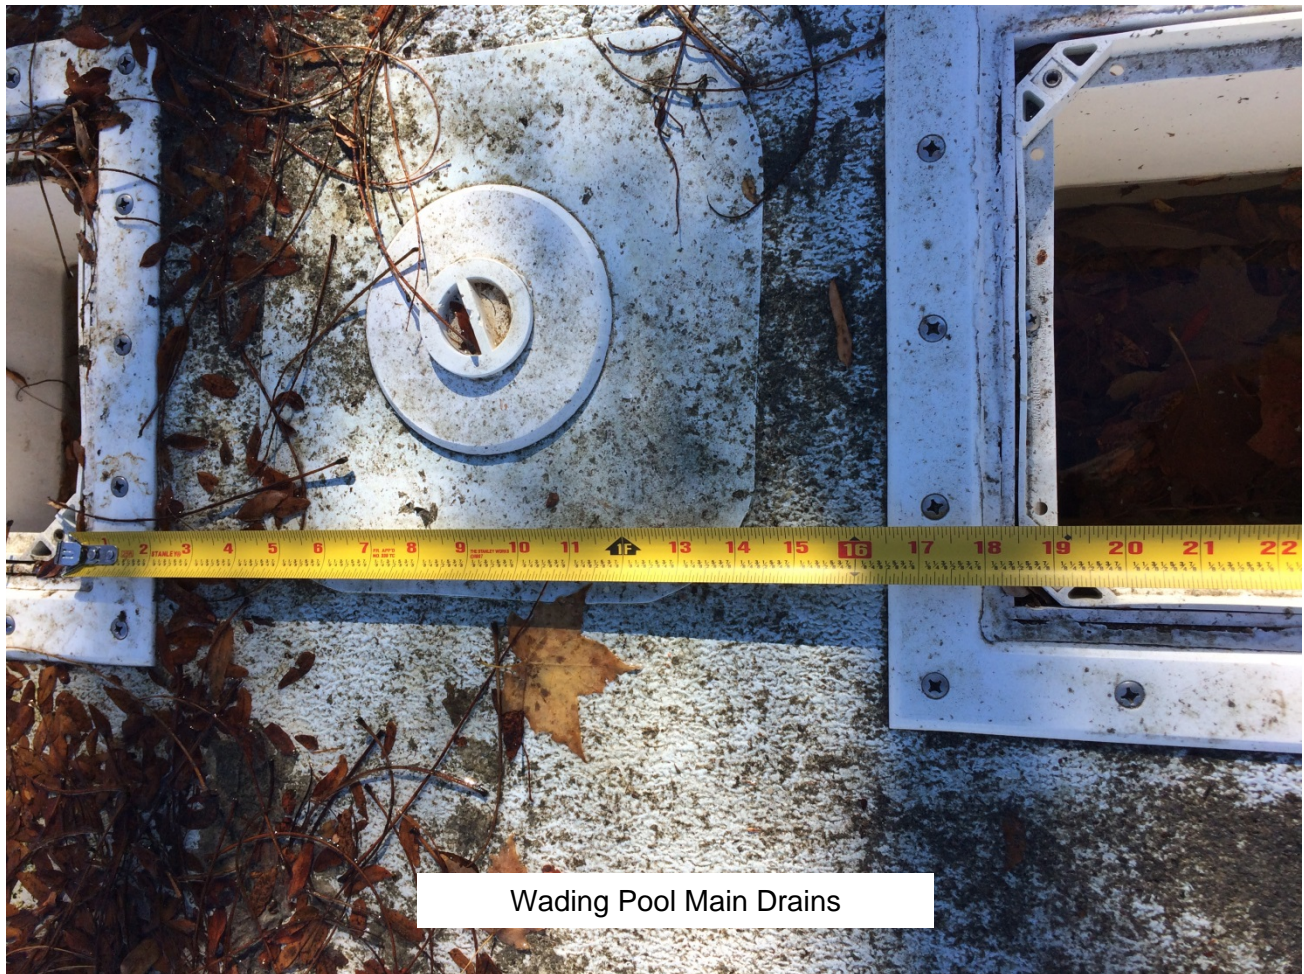
C. Main Drains

The current main drains are less than 3 feet in clear spacing. This is a violation of the Virginia Graeme Baker Act. (VGB)
