MOLD ABATEMENT SPECIFICATION
for
192 Deerfield Road
Windsor, CT 06095

November 5, 2020

**Residential Microbial and Moisture Assessment Report
for
192 Deerfield Road
Windsor, CT 06095**

EnviroMed Project # IH-20-695

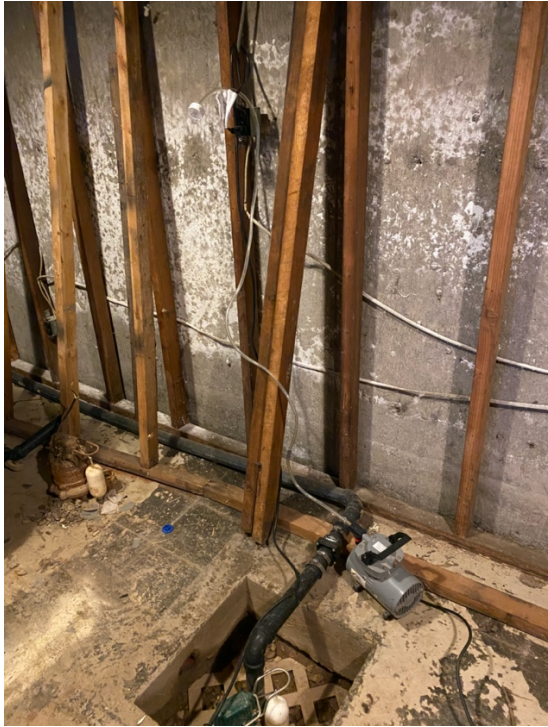
The dominant fungal genus present is *Aspergillus/Penicillium*, which was found to be significantly higher than the baseline and is a common allergen. *Ascospores* was also found to be significantly higher than the baseline and is a common allergen.

Other lower levels of *Alternaria*, *Basidiospores*, *Chaetomium*, *Cladosporium*, *Curvularia*, *Myxomycetes* and *Stachybotrys* were also detected. *Alternaria* and *Curvularia* were not detected in the outside baseline sample, and were detected at low fungal densities in the basement.

Of these lower detections, note that *Chaetomium* and *Stachybotrys* are known water damage indicators and both genera are known to produce toxigenic spores.

Basement

Due to the active mold growth of *Ascospores* and *Aspergillus/Penicillium* found on porous substrates in the basement, as well as the presence of *Chaetomium* and *Stachybotrys* in the air, the basement area is not deemed fit for occupancy. EnviroMed will produce a mold abatement design based on the high levels of allergenic mold and low levels of toxigenic mold found in this area due to water damage. After remediation, it is recommended that sumps remain active and a dehumidifier installed due to previous waster accumulation.

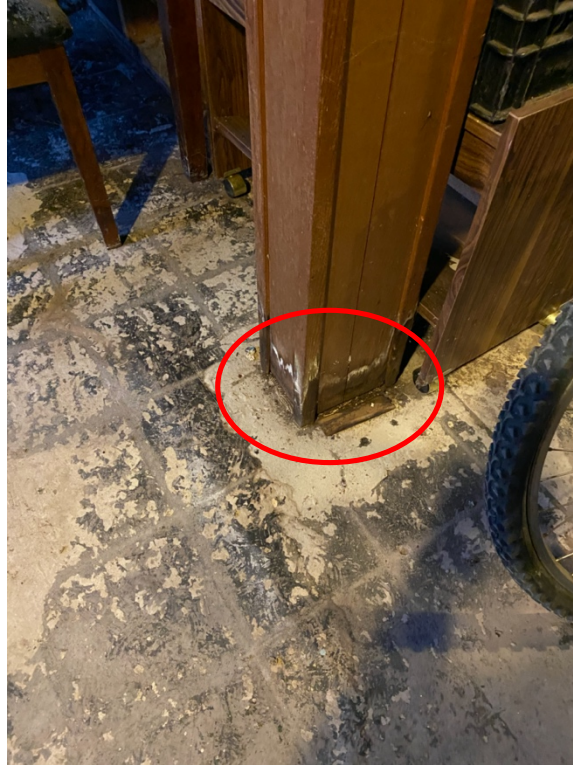
Basement – Base of Wood Covering Structural Column

A very heavy spore estimate and few *Ascospores* and *Aspergillus/Penicillium* mycelium present.

The base of the softwood wood covering the structural column was found to contain moisture near 25%, which indicates moderately wet material. Other porous materials tested such as wood wall bases, wooden wall framing and wooden staircase did not contain moisture above 5%, which indicates dry material.

- The floor and base of the wooden structural column covering and hardwood support contained evidence of water damage.
- The base of the wood covering the structural column contained a very heavy spore estimate of *Ascospores* and *Aspergillus/Penicillium*, which had few active mycelial growth. This genus is classified as a common allergen.

Base of wood covering structural column

Contractor shall remove lower 1' height from floor: wall panels, column casing, framing and insulation, as these items were previously impacted by water.

Contractor shall clean all remaining materials with Fiberlock Shockwave or approved alternate per manufacturer specification.

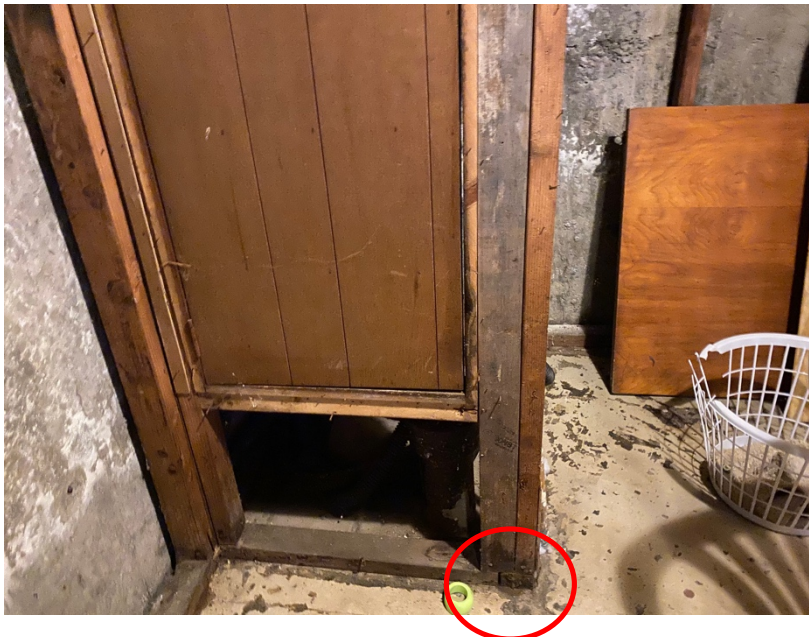
Basement – Base of Hardwood Support

A very heavy spore estimate and many *Ascospores* and mycelium present.

- The base of the hardwood support near the base of the stairs contained a very heavy spore estimate of *Ascospores*, which had few active mycelial growth. This genus is classified as a common allergen.

Base of hardwood support
